TYPE OF SERVICES	Screening Level Phase I Environmental Site Assessment
LOCATION	Hale Avenue Extension Morgan Hill, California
CLIENT	David J. Powers & Associates
PROJECT NUMBER	118-36-2
DATE	March 23, 2016

Type of Services	Screening Level Phase I Environmental Site Assessment
Location	Hale Avenue Extension Morgan Hill, California

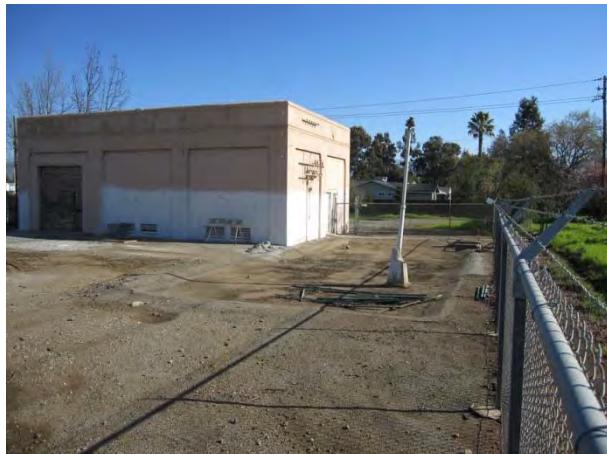
be a single story concrete structure with a roll-up door on the western side. The structure was located within PG&E's substation, which was surrounded by chain-link fencing. Based on our exterior observations, the use of the building was not readily apparent, and Mr. Miller was not familiar with the use or history of the building. A shallow (approximately 1-foot deep) containment basin was observed on the southern side of the building. This basin was paved with deteriorated asphalt and was dry at the time of our visit. The basin appeared likely to have historically been used as a secondary containment feature, probably associated with oil-containing electrical transformers. Discharge piping, controlled by a valve, was observed at the low point of the basin (southeast corner) that discharged into a small on-Site unlined ditch that extended to the east to a storm drain catch basin. The catch basin appeared to discharge via below ground piping to a nearby larger unlined drainage ditch located on the eastern side of the planned roadway alignment. No evidence of spills into the containment basin or the associated drainage ditch were readily apparent.

Photograph 1. On-Site PG&E building and secondary containment basin, looking northeast.

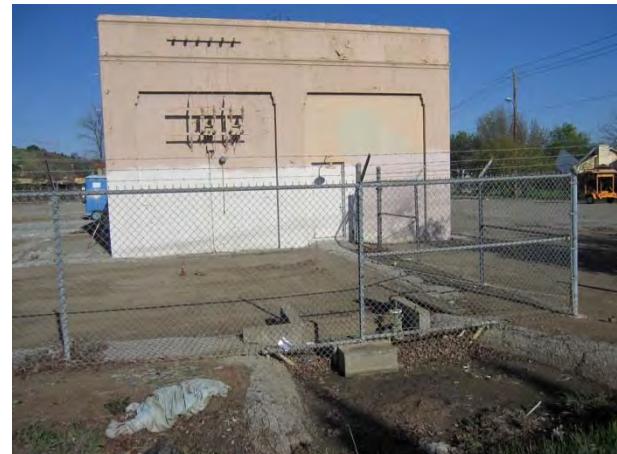
Photograph 2. PG&E building, and discharge piping and valve at the southeast corner of the secondary containment basin.

Historical aerial photographs depict several electrical transformers just west of the planned roadway alignment at the PG&E substation. A nearby containment basin (located partially on-Site) is present on the southern side of the on-Site PG&E building. This basin is paved with deteriorated asphalt and likely was historically used as a secondary containment feature associated with oil-containing electrical transformers. Discharge piping, controlled by a valve, is present at the low point of the basin (southeast corner) that discharges into a small on-Site unlined ditch that leads east to a storm drain catch basin. Based on the regulatory agency databases reviewed during this study, no chemical releases at the PG&E substation have been reported. However, for a higher degree of certainty, we recommend that soil sampling and laboratory analyses be conducted to evaluate soil quality at the locations where the planned roadway traverses the PG&E containment basin and associated drainage ditch. Historically, transformer oil commonly contained polychlorinated biphenyls (PCBs); other common contaminants include petroleum hydrocarbons and metals.

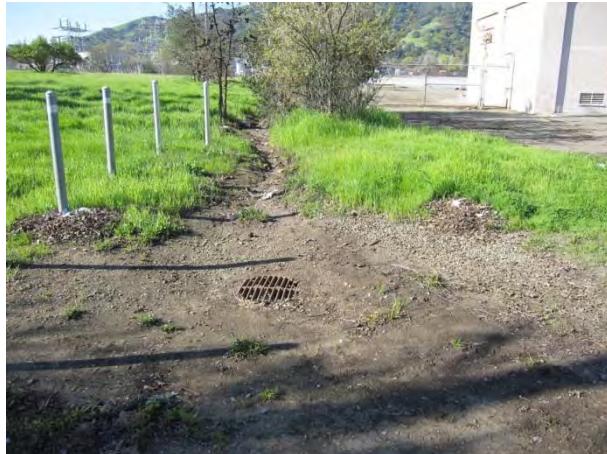
Photograph 3. Drainage ditch leading from the secondary containment basin to a storm drain, looking west.

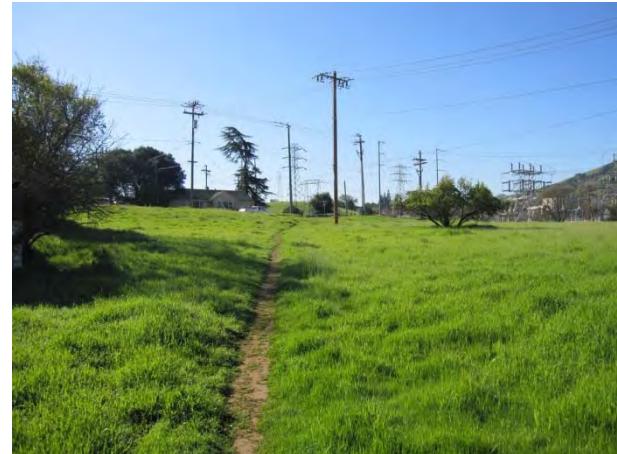
Photograph 4. View of the planned roadway alignment looking south from the PG&E building area.

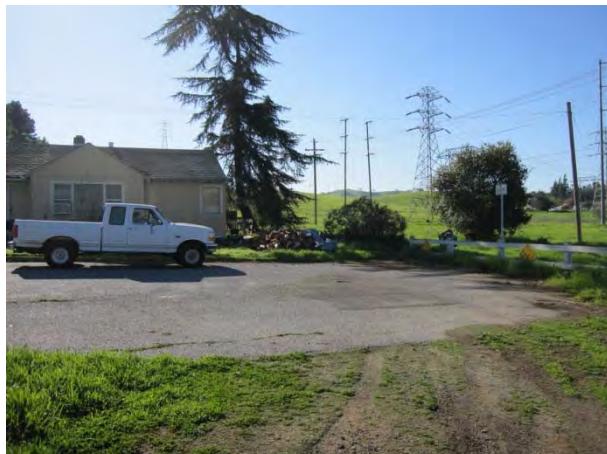
Photograph 5. On-Site residence and western terminus of Warren Avenue, looking south.

Prior to the implementation of earthwork activities at the Site, we recommend that shallow soil adjacent to the on-Site residence at the western terminus of Warren Avenue be evaluated for the possible presence of lead and pesticides. Soil adjacent to the concrete PG&E building also should be evaluated for the possible presence of lead.

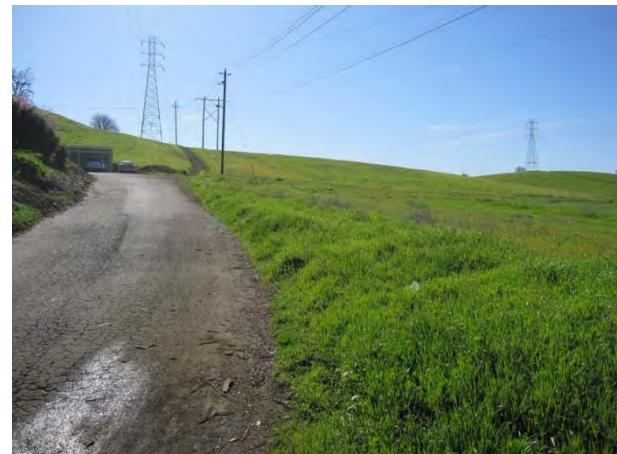
Photograph 6. View of the planned roadway alignment over Nob Hill, looking south.

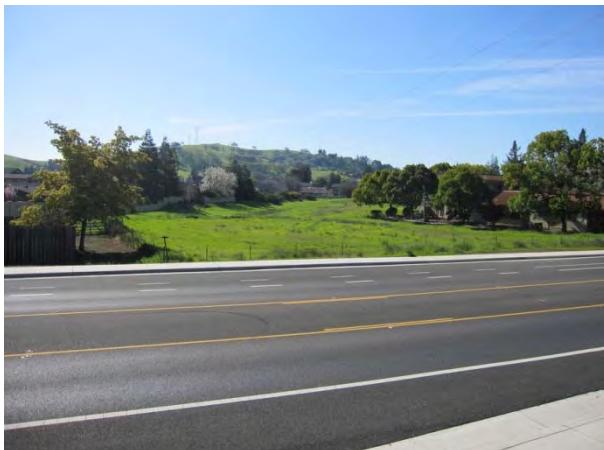
Photograph 7. View of the planned roadway alignment looking south from West Dunne Avenue.

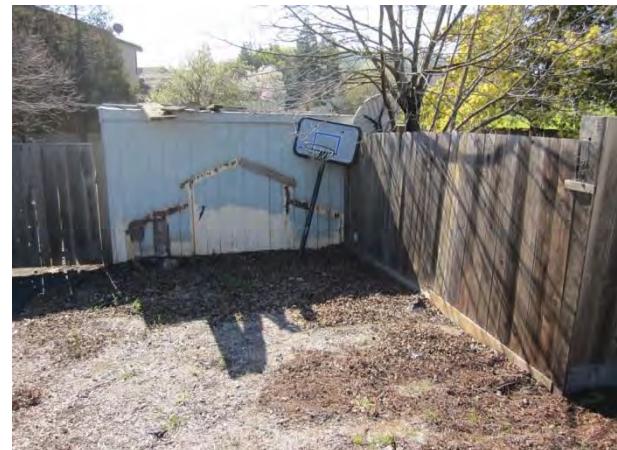
Photograph 8. View of the on-Site shed (and fencing) at the West Dunne Avenue intersection.

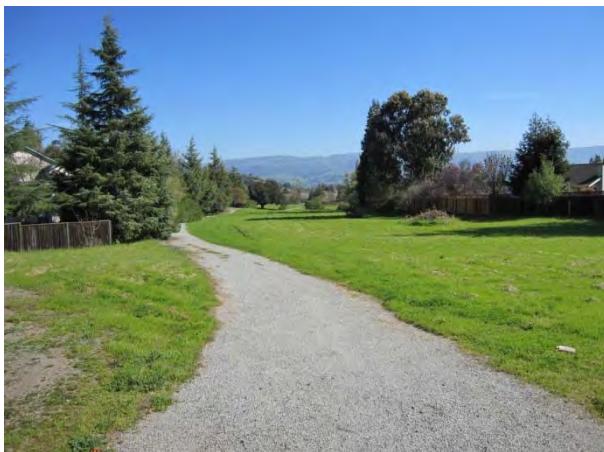
Photograph 9. View of the planned roadway alignment looking northeast from Dewitt Avenue.

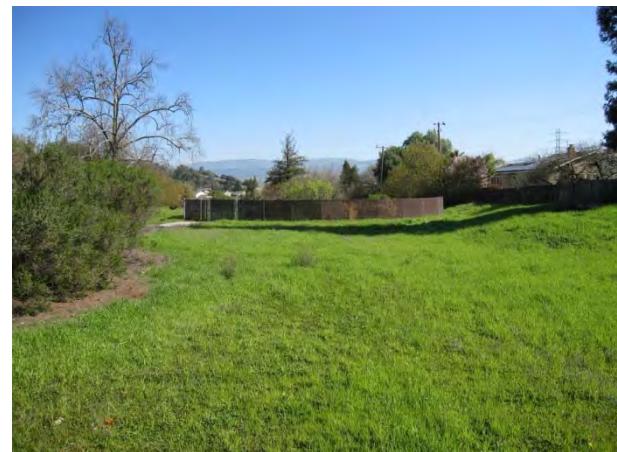
A fenced storm water detention basin was observed on the southern portion of the Site. No hazardous materials were observed on-Site.

Photograph 10. View of the fenced storm water detention basin on the southern portion of the Site, looking northeast
