| TYPE OF SERVICES | Phase I Environmental Site Assessment and Soil Quality Evaluation |
| LOCATION | Villages at Jackson Square 16480 Hill Road Morgan Hill, California |
| CLIENT | David J. Powers & Associates |
| DATE | October 20, 2020 |

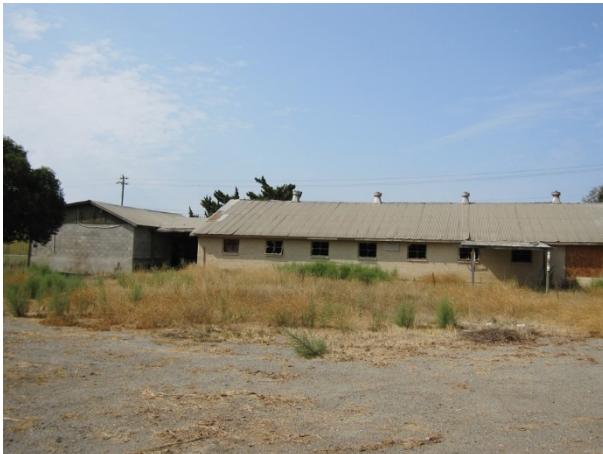
Photograph 1. Milking and storage structure, looking west.

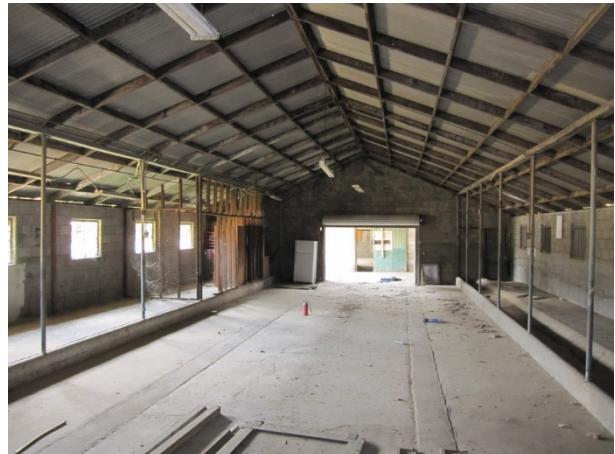
Photograph 2. Interior of milking structure.

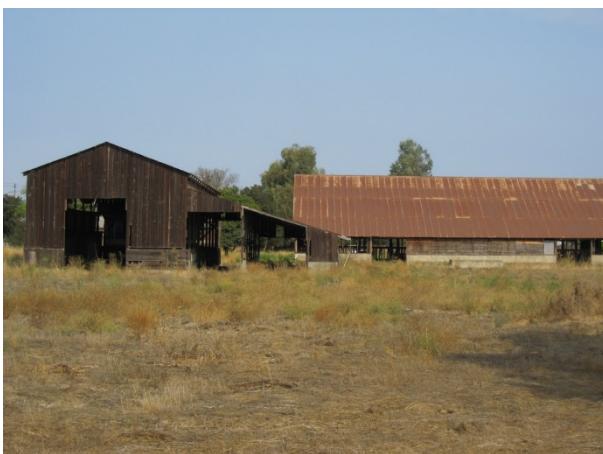
Photograph 3. Cattle feeding and hay storage structures, looking north.

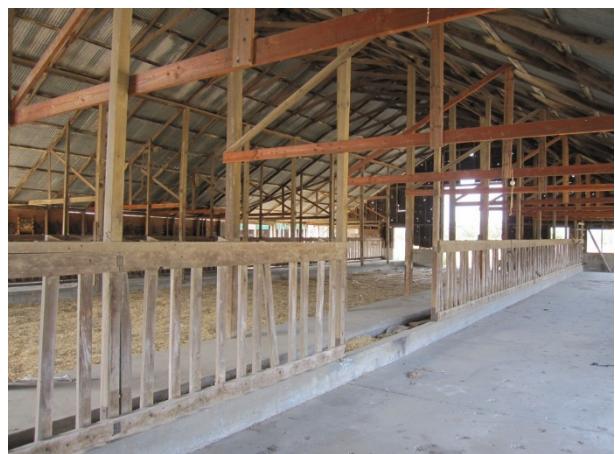
Photograph 4. Interior of feeding and hay storage structure.

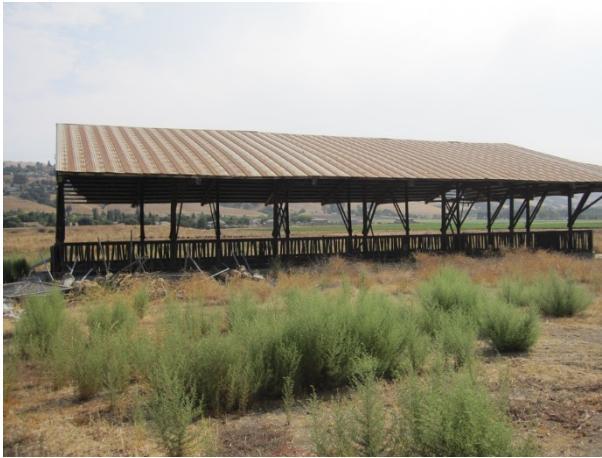
Photograph 5. Apparent cattle holding pen, looking east.

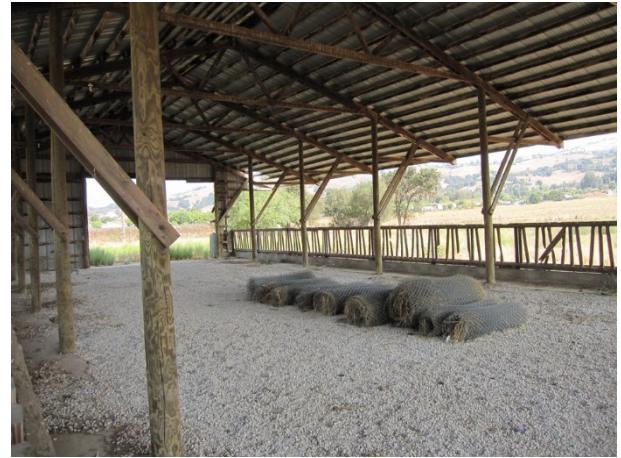
Photograph 6. Interior of holding pen.

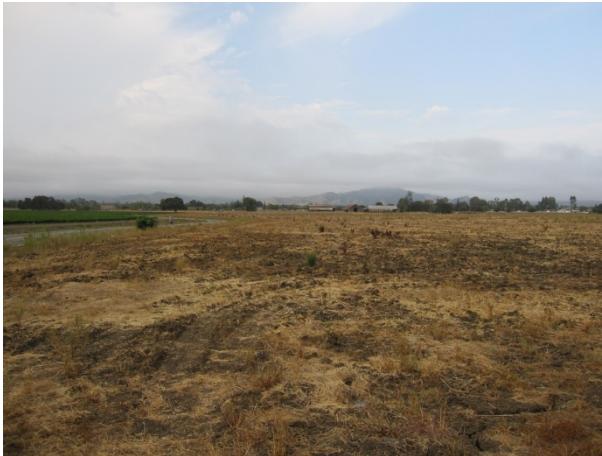
Photograph 7. Fallow agricultural land, looking west.

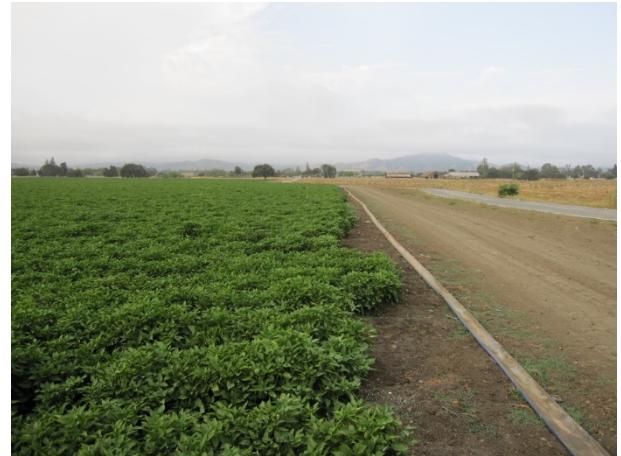
Photograph 8. On-Site row crops south of Barrett Avenue, looking west.

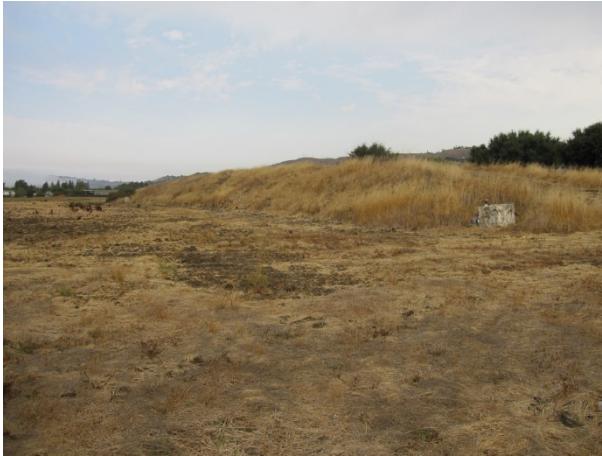
A large soil stockpile, approximately 15 feet in height, was observed on the eastern portion of the Site (just west of Sorrel Drive). Based on information obtained via email from the City of Morgan Hill, the stockpiled soil was generated during construction of residences on the east side of Sorrel Drive by Arcadia in the 1990s.

Photograph 9. Soil stockpile, looking north.

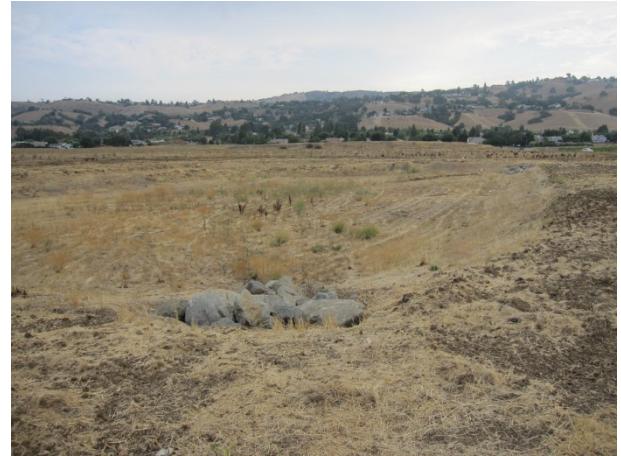
Photograph 10. Stormwater detention basin, looking east.

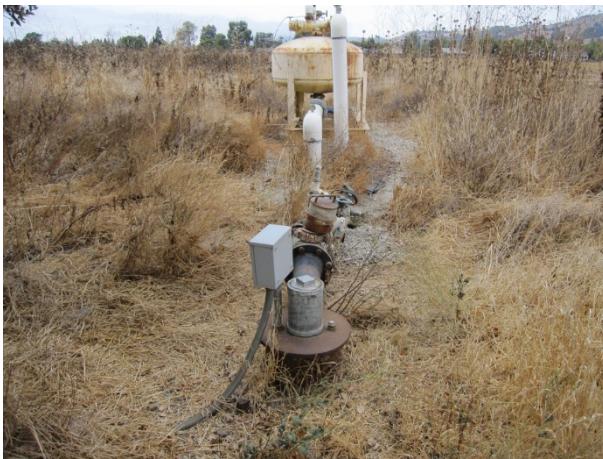
Photograph 11. One of two water supply wells.

Two water supply wells were observed on-Site. Abandoned wells (*i.e.*, those that are not properly destroyed) can act as a conduit for the vertical migration of groundwater contamination. Also, if groundwater levels rise, an abandoned well can become an artisan well with uncontrolled water flow that can adversely impact future developments. Prior to redevelopment of the Site, all on-Site wells not intended for future use should be properly destroyed in accordance with Santa Clara Valley Water District (Valley Water) Ordinance 90-1.

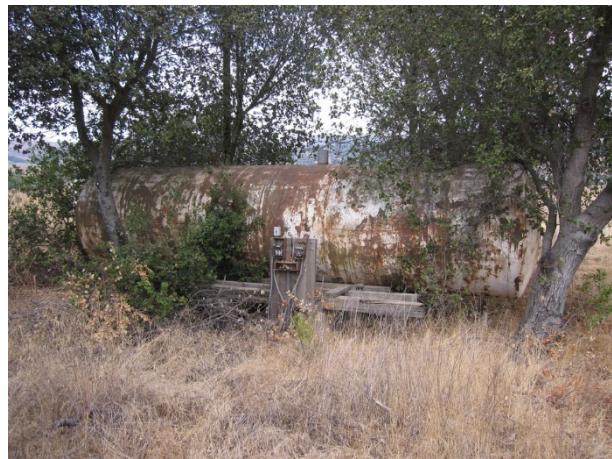
Photograph 12. Apparent water pressure AST.
