APPENDIX E

Architectural Survey Report

PRIMARY RECORD

Page 1 of 27 *Resource Name or #: (Assigned by recorder) 16480 Hill Rd. Morgan Hill CA

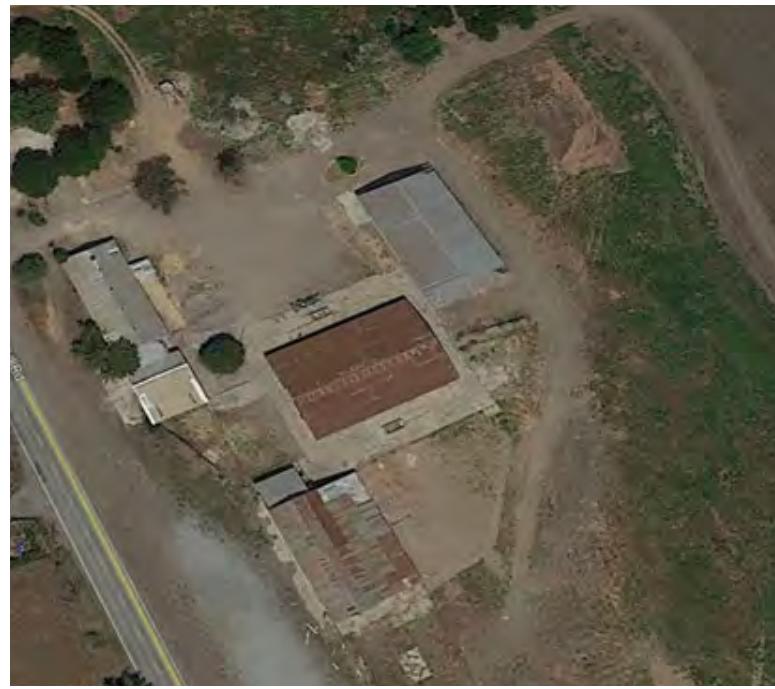
Milk Shed 1 (photos 1,2): Constructed c. 1960. The milking barn is constructed of concrete block with a concrete floor and wood frame roof. Square windows are evenly spaced along both side walls, approximately at each milking station. (continued page 2)

P5b. Description of Photo: (view, date, accession #) Dairy complex

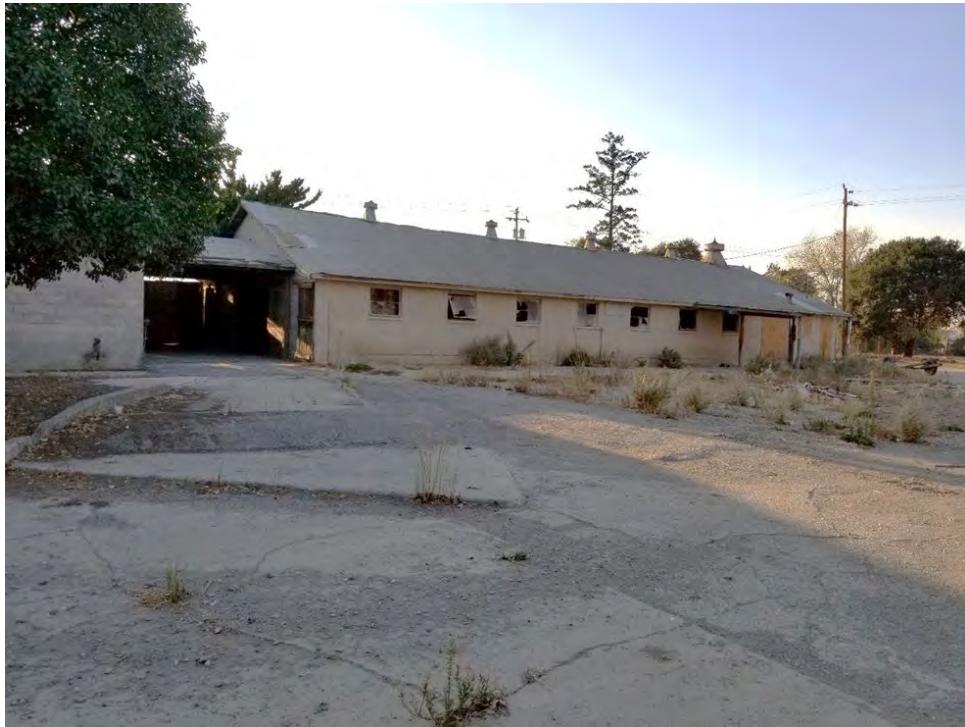
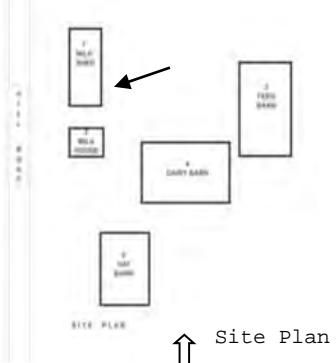
Photograph 1 16480 Hill Road- Milk Shed/Office 1
View: Exterior of c.1965 Milk barn and Shed. The later milking barns had mechanical ventilation (fans) that circulated the air.
Date Constructed: C 1965
Camera Facing :west (Hill Road is behind building)

The floor is stepped to allow the cows to be washed and milked and the dairy workers to walk above the water. Drains in the floor run the length of the building. All milking and other equipment has been removed. The roof of this structure is covered with corrugated sheet metal that is rusted and lifting along the edges of the pieces.

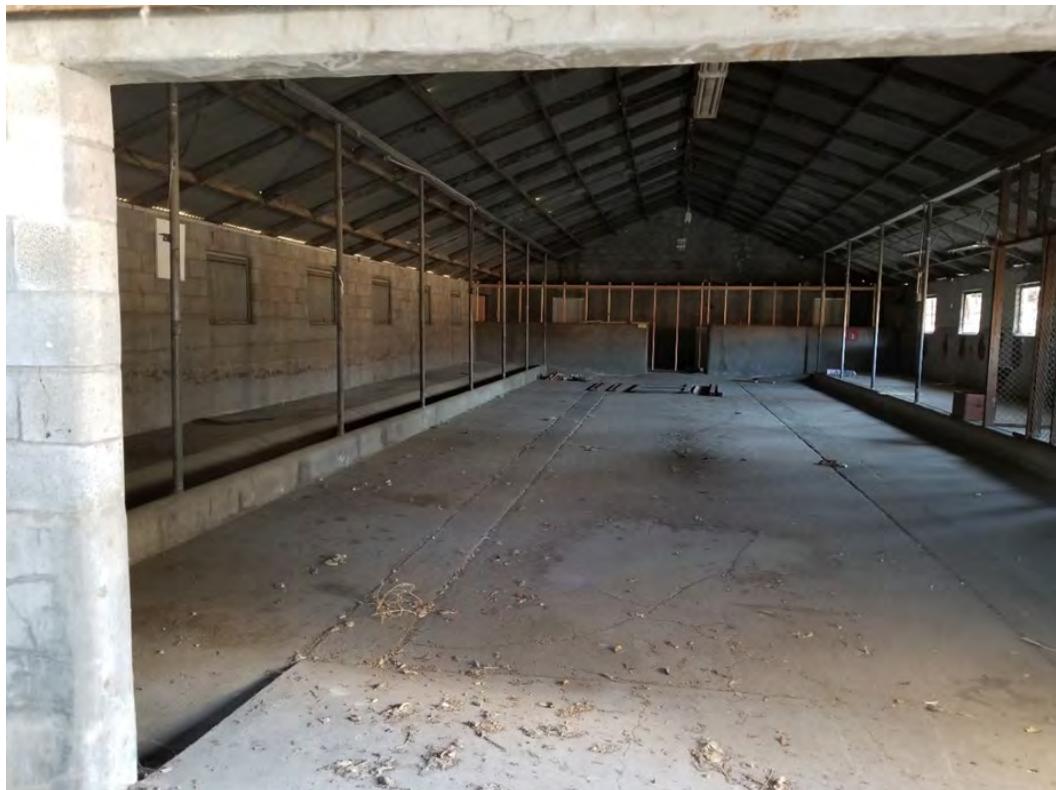
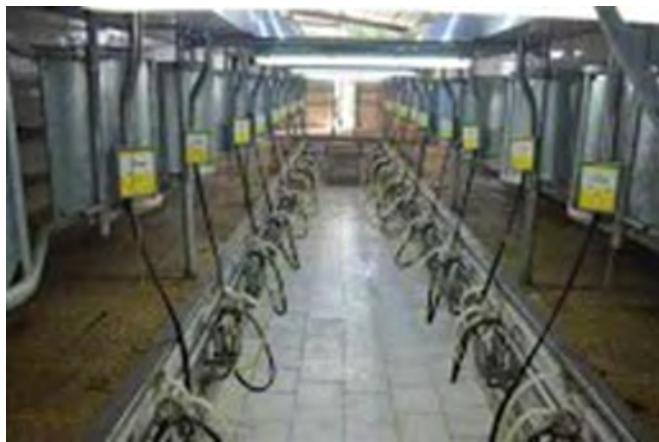
Photograph 2 16480 Hill Road-interior of the Milk parlor Building 1

View: Upper image: the c. 1965 milking barn that used automatic milking machines and ventilation (removed)
Camera facing south

View: lower Image: Interior of a typical milking barn with milking equipment.

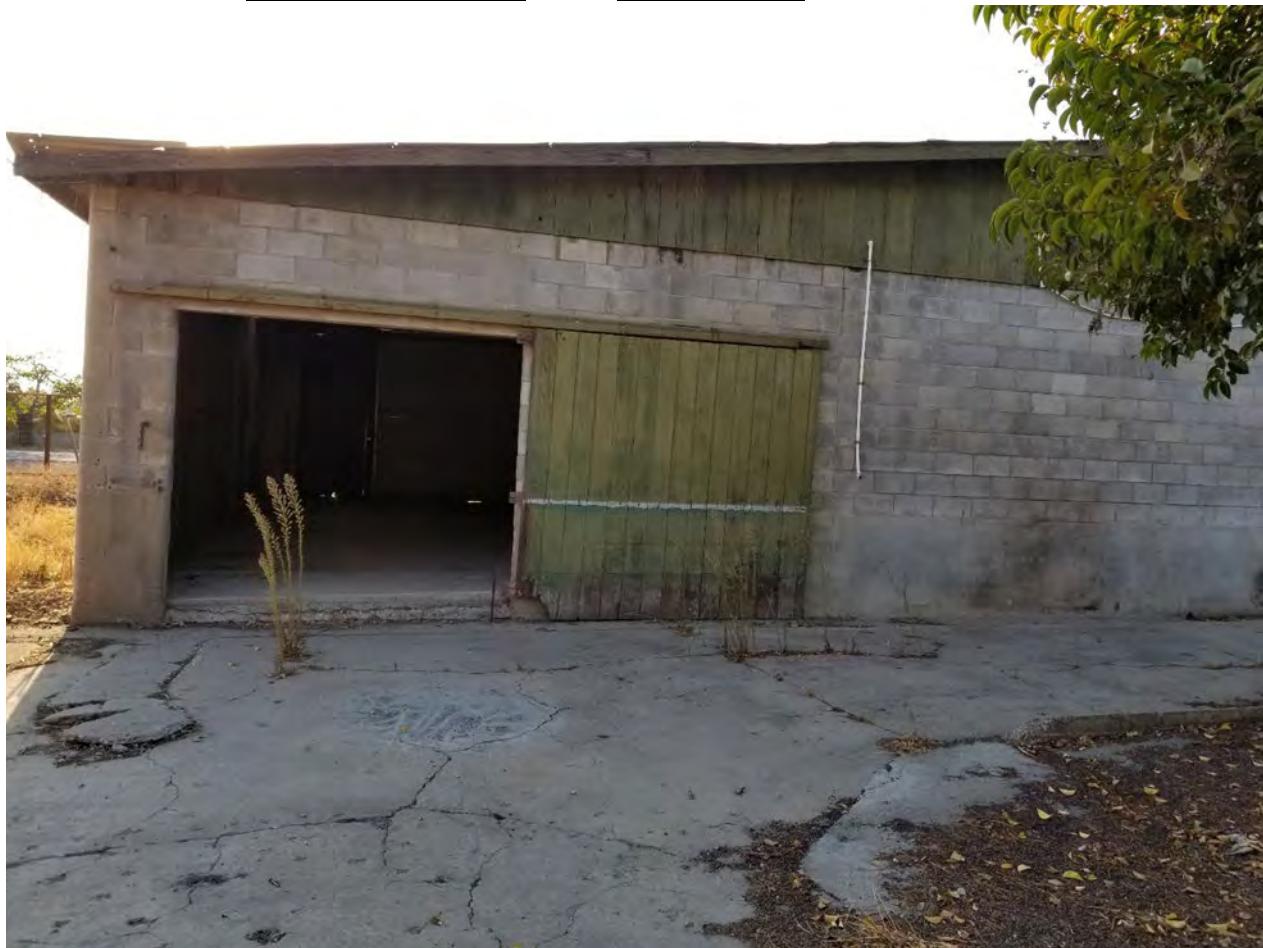
Photograph 3 16480 Hill Road- (Building 2) Milk House
View: Exterior showing the sliding door of the concrete block Milk cooling building.

Date Constructed: c.1951-52

"Milk House" Cooling building (Building 2, Photographs 3,4) C. 1960:

This rectangular building with a pitched (gable) roof, has walls that are constructed of concrete blocks with few openings. A single sliding door is on one side. This building originally used to store milk after milking, has recently been used as housing(squatters) and has been extensively vandalized inside.

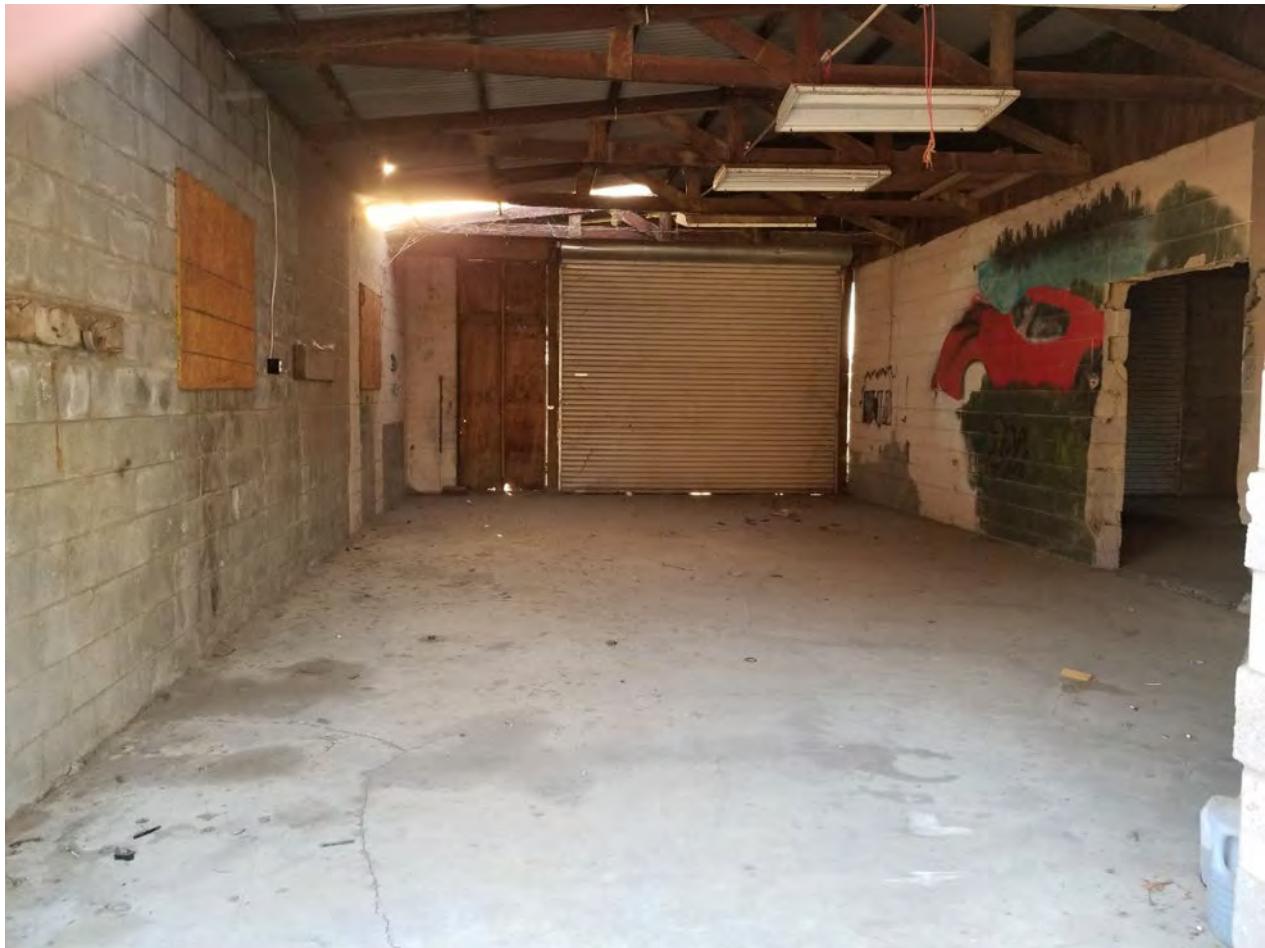
Photograph 4 16480 Hill Road - (Building 2) Milk House

View: Interior of concrete block cooling building. Containers of milk were kept in this cooling building until picked up by a refrigerated truck.

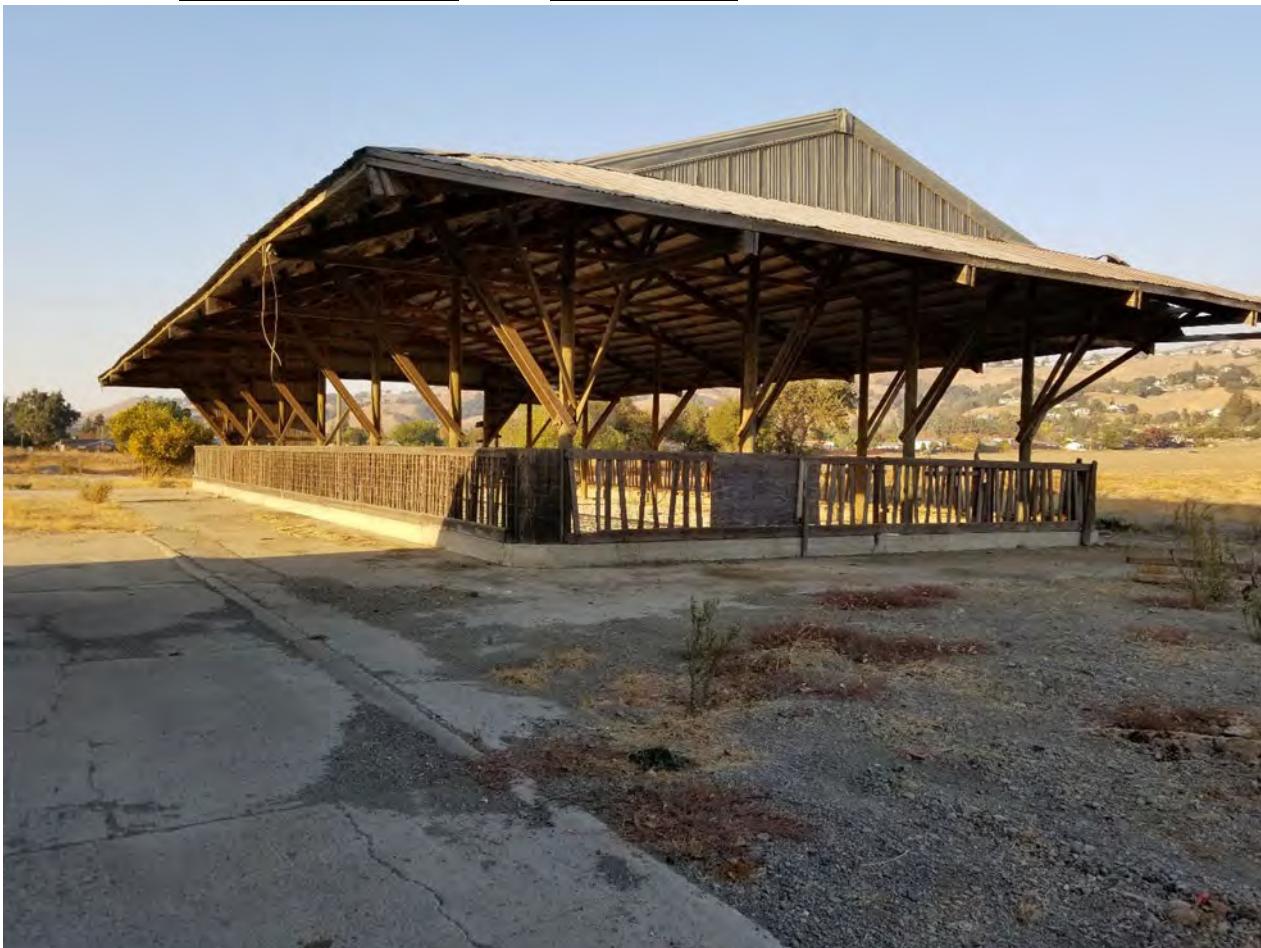
Photograph 5 16480 Hill Road- (Building 3) Feed Barn C. 1971 or later
View: The last structure to be constructed on the property is an open structure that appears to be a milking parlor/holding (feed) pen.
Camera facing: Southeast

Feed Structure (Building 3, Photographs 5) c. 1971:

this appears to be the youngest of the structures and is the most interesting for its structural design.

The wood structure is open under a large roof. The sides have slatted sides where the cow can insert their head and have a portioned amount of feed available. The structure has feeding stalls on both sides and an open center where the feed was stored. The roof is covered with corrugated sheet metal. The floor is concrete. This appears to be the newest structure on the property, a more modern version of the previous Milk House barn (Building 1). The condition of this structure is the best of any on the site, still it has not had maintenance in quite a while.

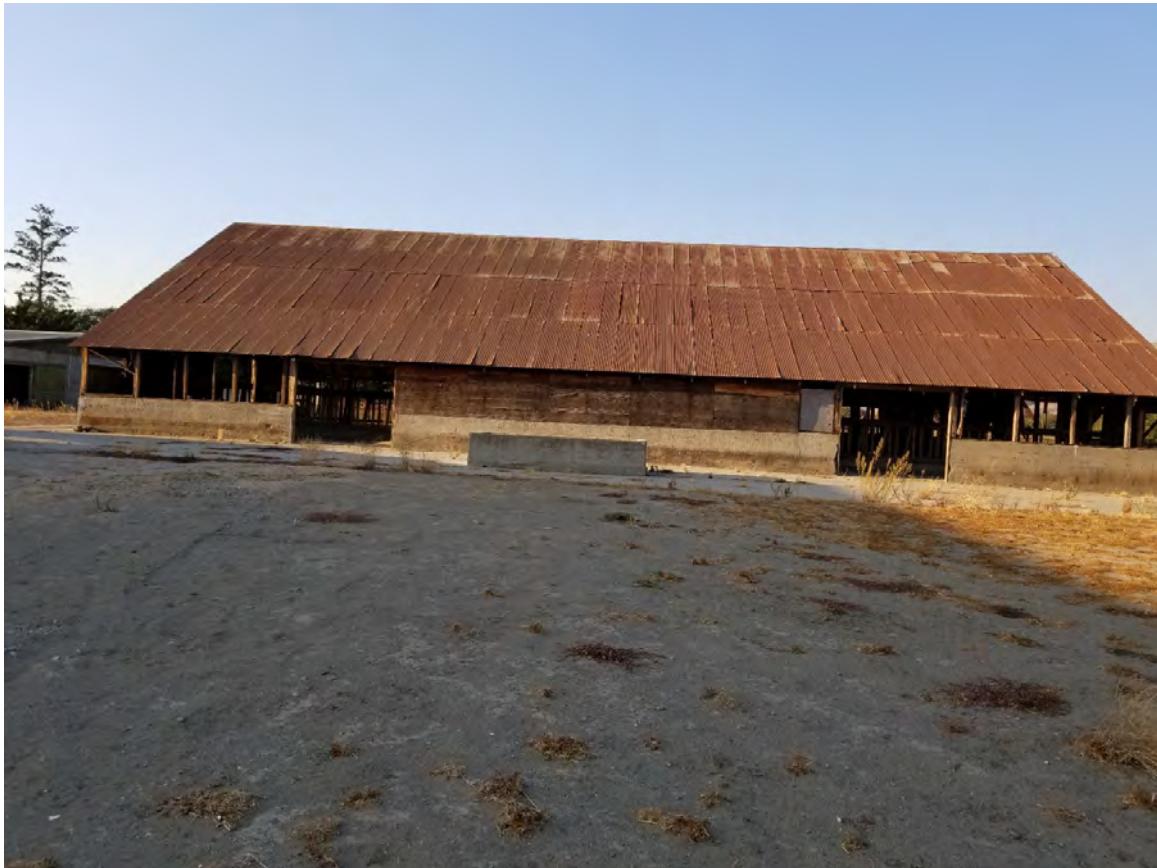
Photograph 6 16480 Hill Road, Morgan Hill -(Building 4) Dairy Milk Barn

View: Building #3 original open sided barn, west side, c. 1951
Camera facing: east

Dairy Milking Barn (Building 4, Photograph 6,7,8) c.1952:

This structure has a low concrete block perimeter wall that has openings for the cows to enter. The upper half of the walls is open, the lower has horizontal board siding on the east and west sides. The roof is a central gable with shed additions and is covered with corrugated sheet metal. The interior retains the slatted wood feed cribs. The building is in extremely poor condition with damage to the interior structure.

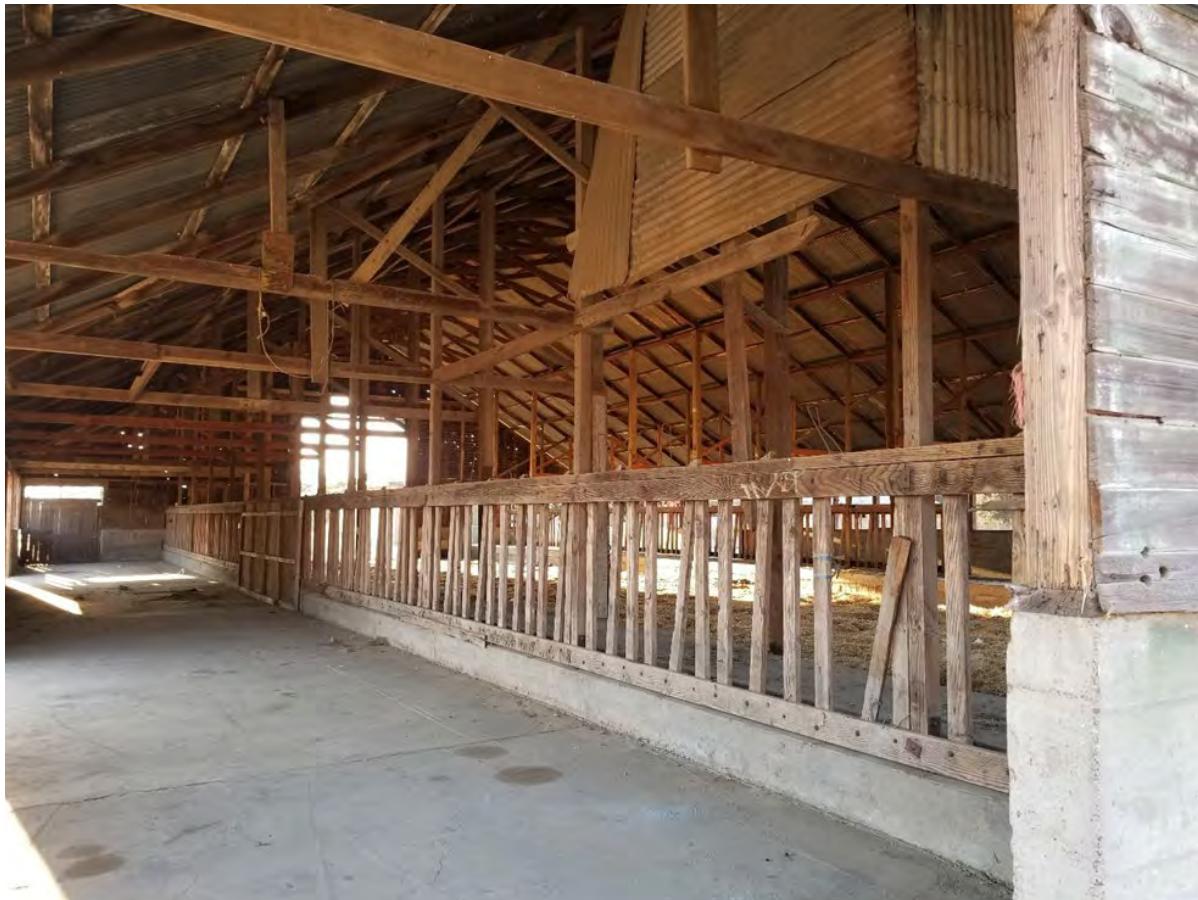
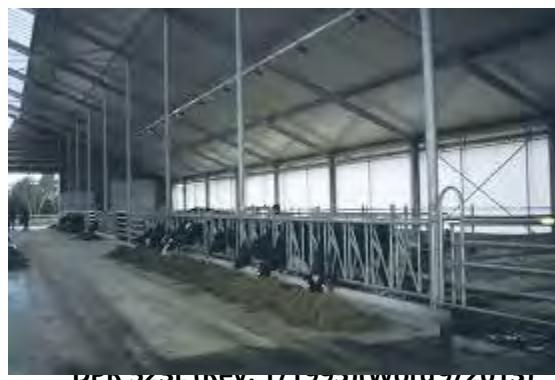
Photograph 7 16480 Hill Road (Building 4) Dairy Milking Barn
View: Interior of the open sided barn. Stanchions form the holding structure for feeding the cattle.

View: lower Image: Interior of a typical feed barn

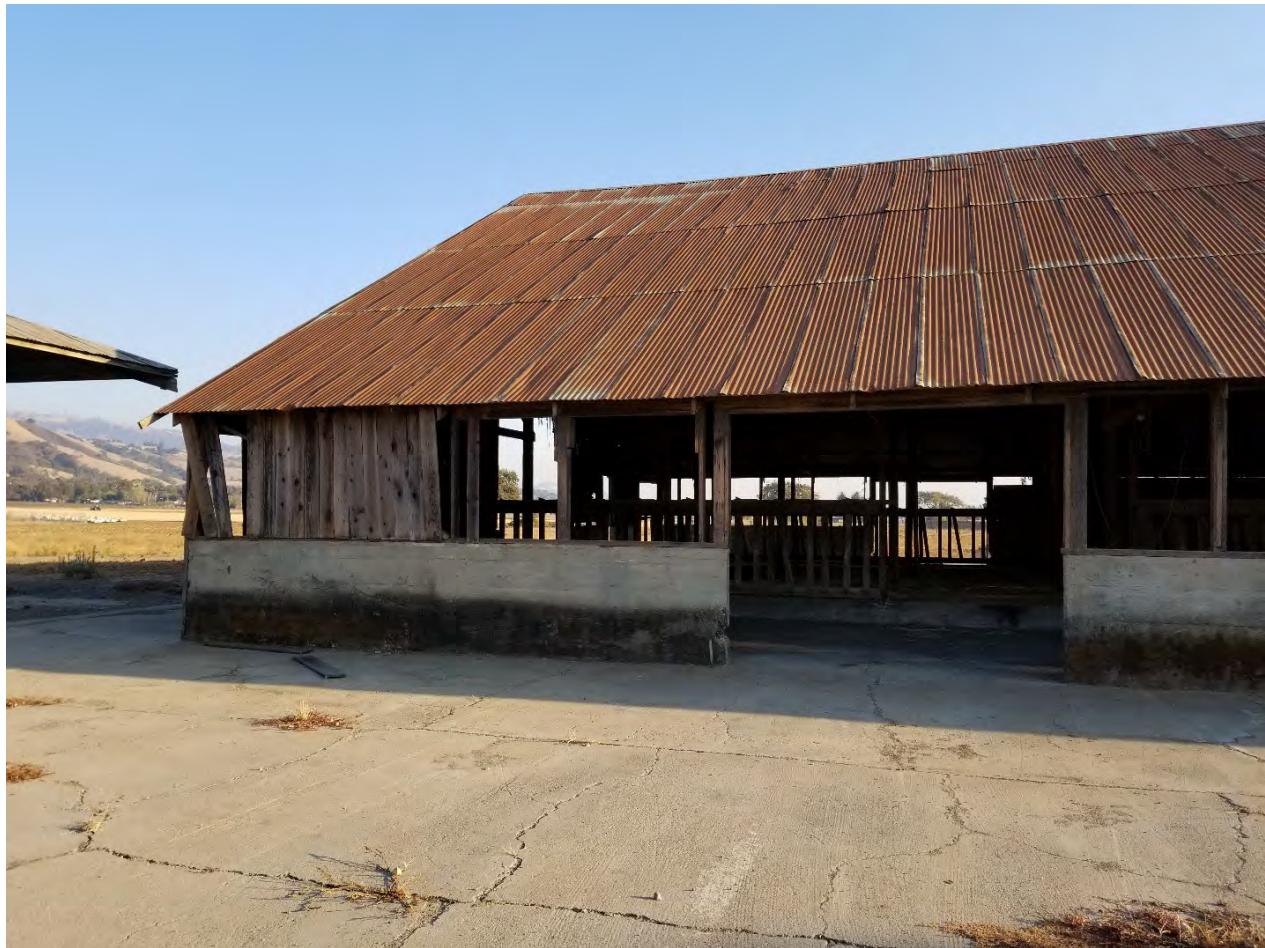
Photograph 8 16480 Hill Road (Building 4) Dairy Milking Barn

View: Exterior corner showing the half wall concrete block construction and open sides.

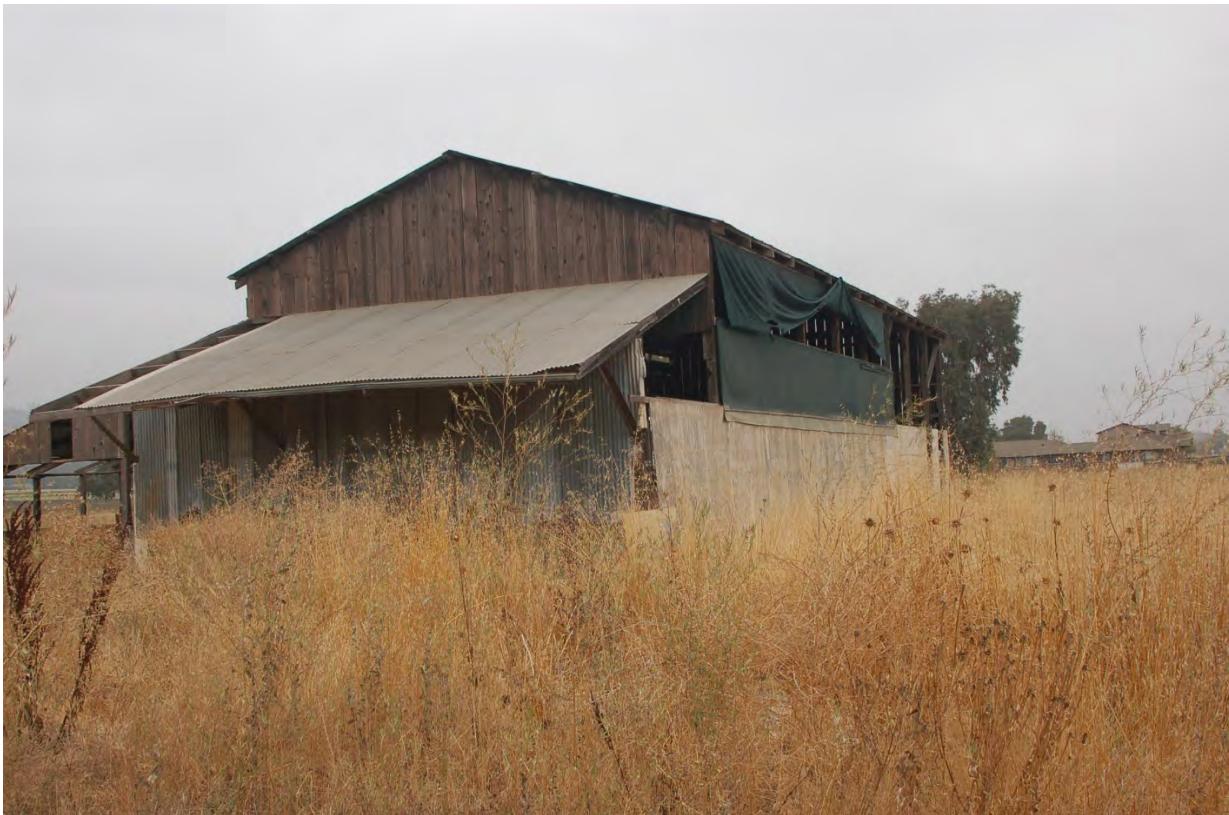
Photograph 9 16480 Hill Road – (Building 5) Hay Barn c.1930
View: West side of shed and barn.

Hay Barn (Building 5, Photographs 9,10): This is the oldest building on the property and appears to have been constructed c. 1930.

The Wood frame structure exhibits a central timber structure with a gable roof that is covered in Corrugated metal sheets. The south end has a large opening in the vertical board siding. The vertical board siding on the other sides is severely deteriorated showing broken boards and openings in the walls. A shed addition is attached to the east side of the structure. It too, is wood frame with a slanted roof covered in corrugated metal sheets.

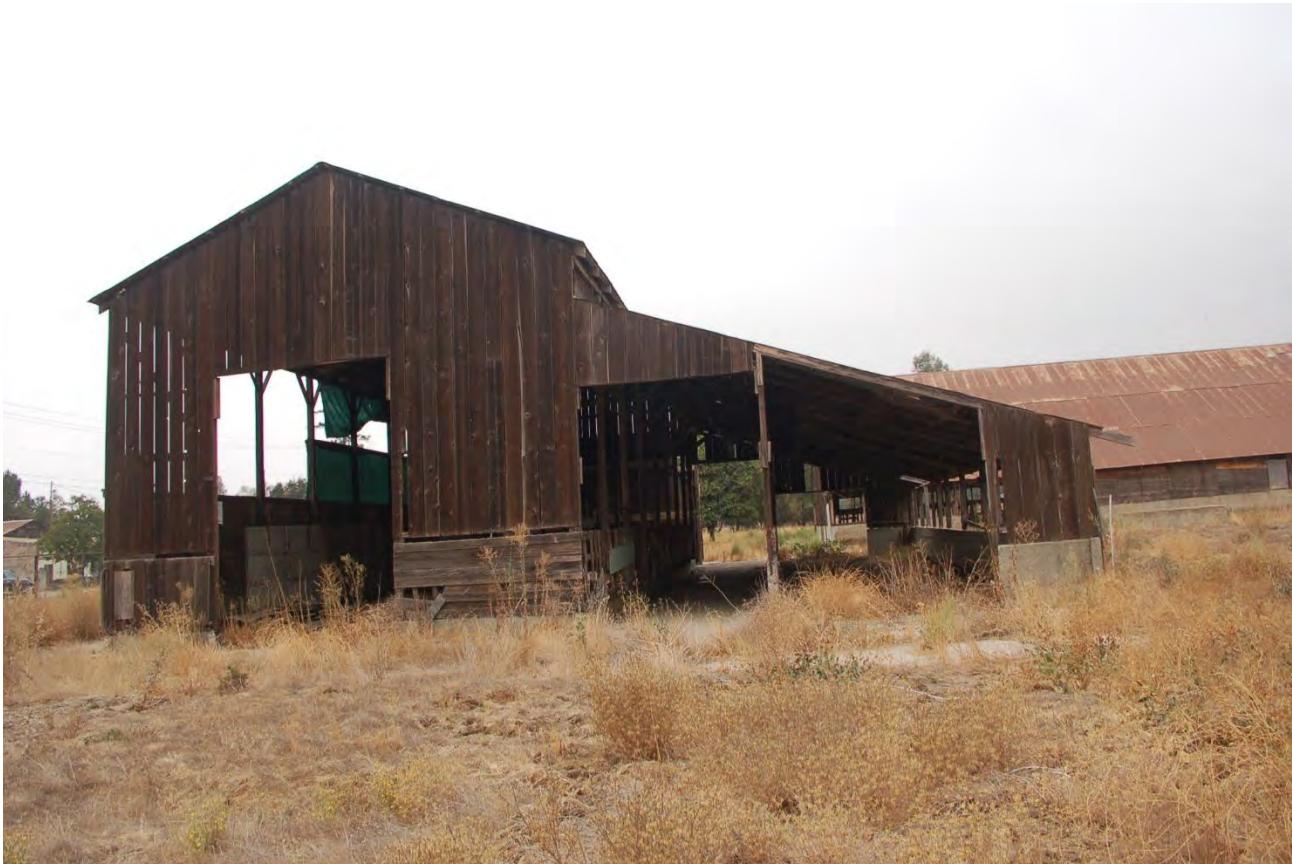
Photograph 10 16480 Hill Road - (Building 5) Hay Barn c.1951

View: End and side of the abandoned hay barn.

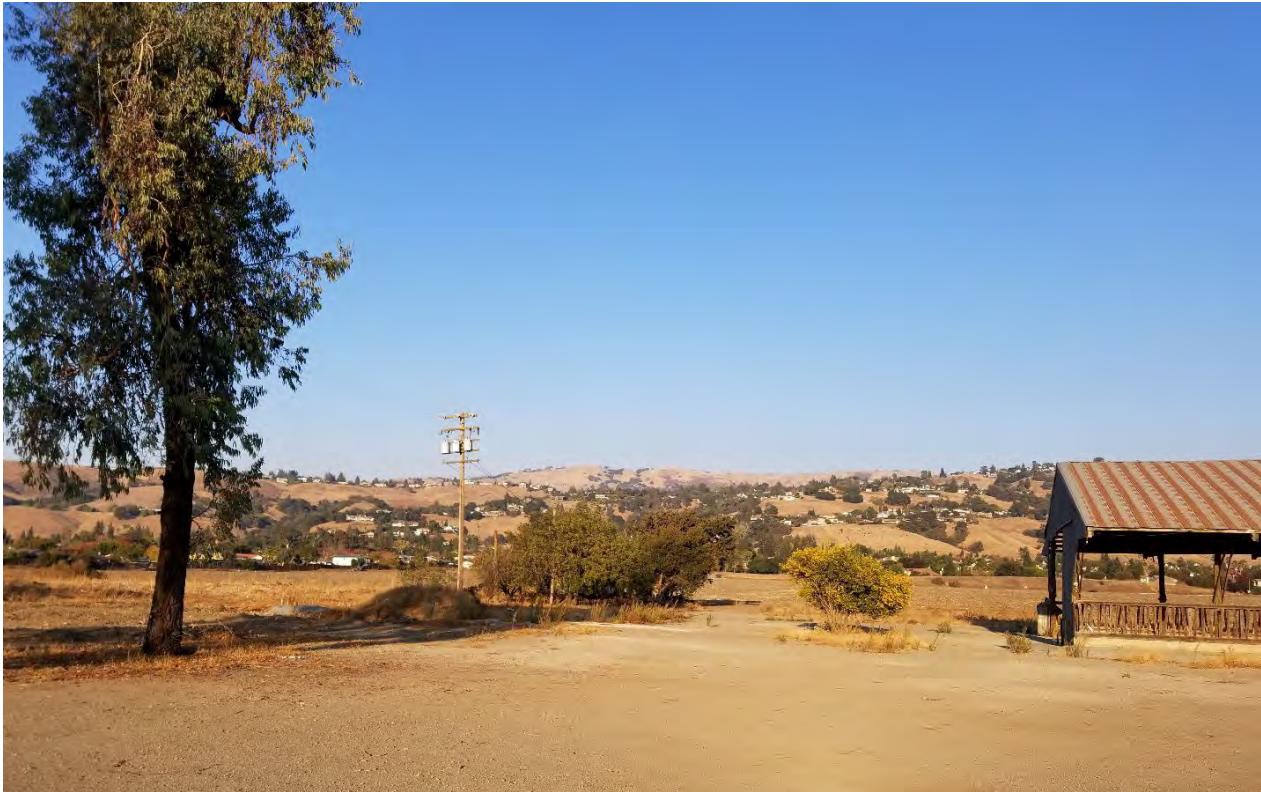
Photograph 11 16480 Hill Road

View: Looking East beyond the milking sheds and barns toward the vacant fields of the 68 acres site

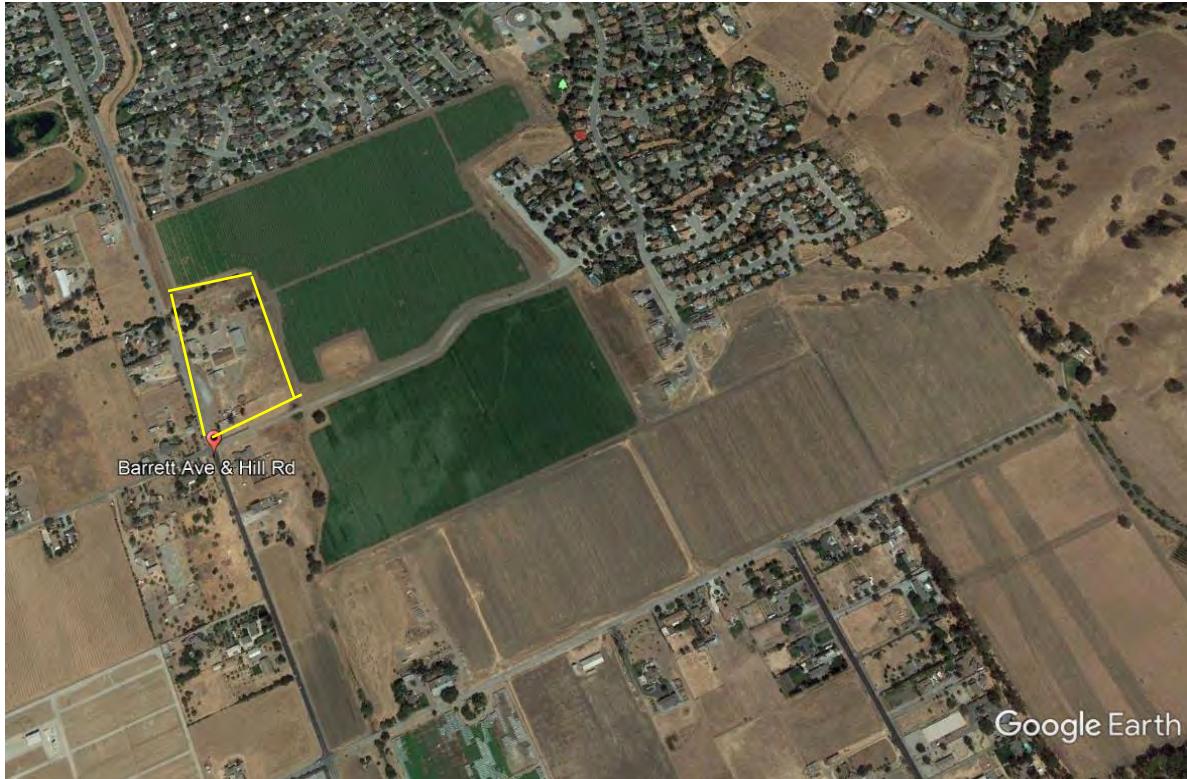
Photograph 12

16480 Hill Road, Morgan Hill CA

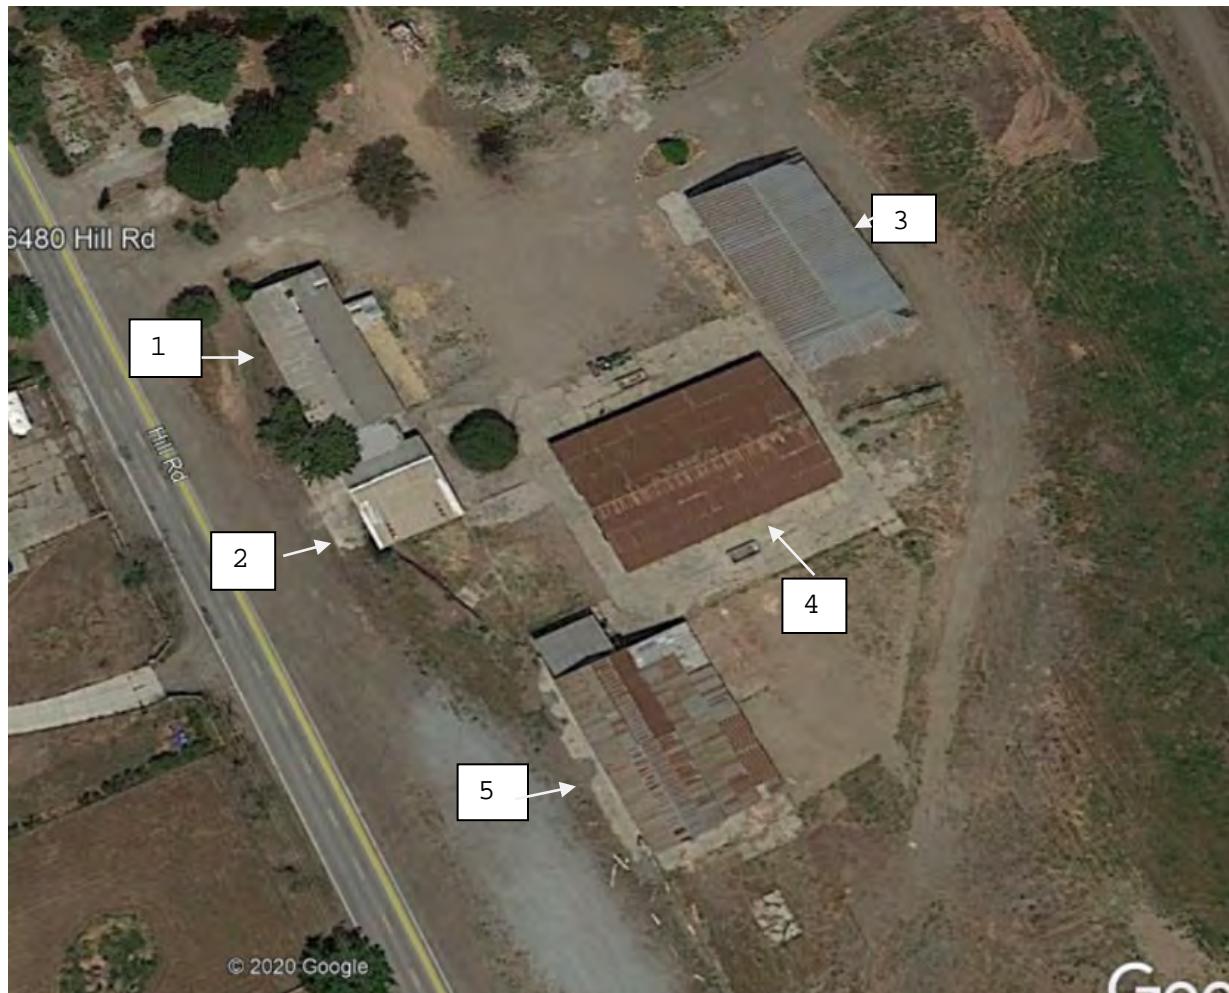
Aerial Map of the Dairy complex at 14680 Hill Road, Morgan Hill CA

Building 1 Milk Shed

Building 2 Milk House

Building 3 Feed Barn

Building 4 Dairy Barn

Building 5 Hay barn
