PRIMARY RECORD

*Resource Name or #: (Assigned by recorder) 730 Diana Avenue

c. Address 730 Diana Avenue City Morgan Hill Zip 95037

BUILDING, STRUCTURE, AND OBJECT RECORD

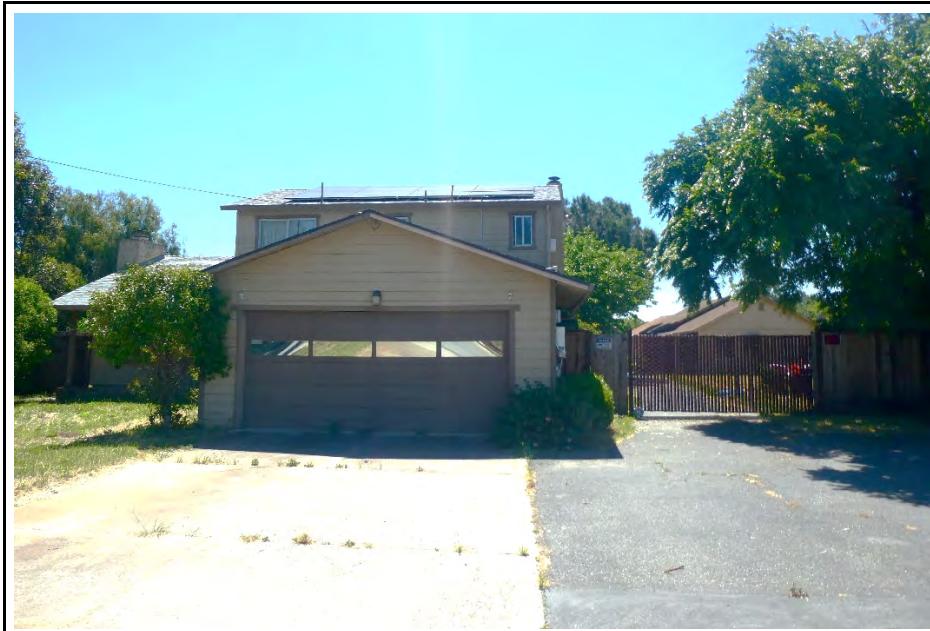
P5b. Description of Photo: (view, date, accession #) N elevation, 05/2024

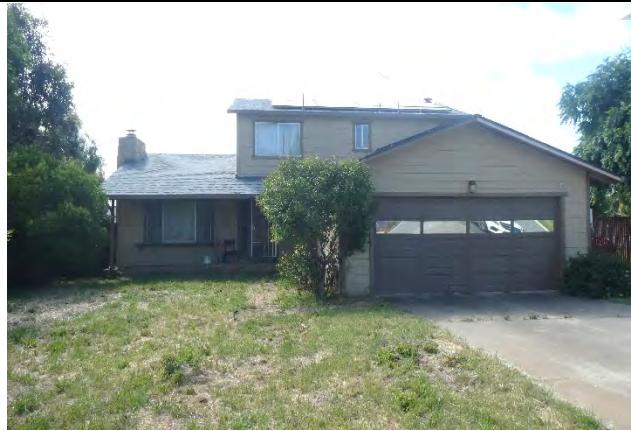
Image 1: Building A, north elevation, view facing south. Source: GPA, May 2024.

Building A fronts Diana Avenue and has an L-shaped plan with a one-story volume oriented north-to-south that intersects a recessed, one and partial two-story volume that is oriented east-to-west. The building features gable roof forms, stucco and wood cladding, and aluminum frame windows and doors (see Images 1 and 2 on Page 12).

The north (primary) elevation has a one-story projecting plane in front of a one and two-story plane. The main entryway is located on the first floor of the recessed plane, under a covered porch clad in brick and concrete. The entryway consists of a single wood door behind a metal screen door. The door opening is flanked to the west by a narrow, double-hung, aluminum frame window. To the east of the door opening is a wood sidelight with tinted glass and an aluminum frame, tripartite window grouping. The second story of the recessed plane is half the length of the first story. It features one large pair and two small sliding aluminum frame windows. The projecting plane consists of a two-car garage with a rollup, paneled metal door with four mirrored panels.

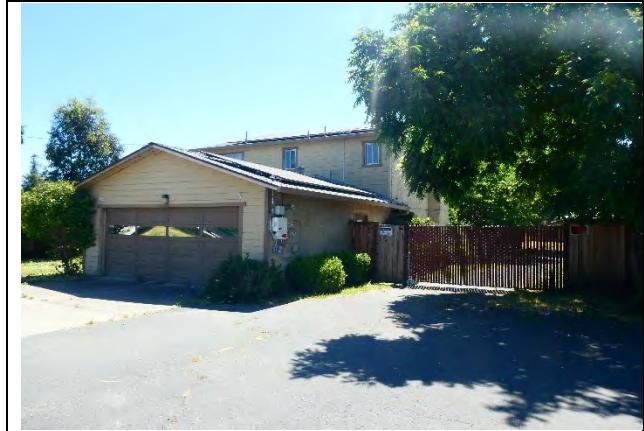
Image 2: Building A, north (left) and west (right) elevations, view facing southeast. Source: GPA, May 2024.

The west (side) elevation faces the side yard and neighboring property and is a flat plane that is one-story to the north and two-stories to the south (see Image 2 on Page 12). The entire elevation is clad in a heavily textured stucco. A metal vent is located in the peak of the forward facing gable along with a two-story chimney. Fenestration is limited to a partially-glazed wood door, a pair of aluminum frame windows, and an air conditioner within a possible infilled window opening.

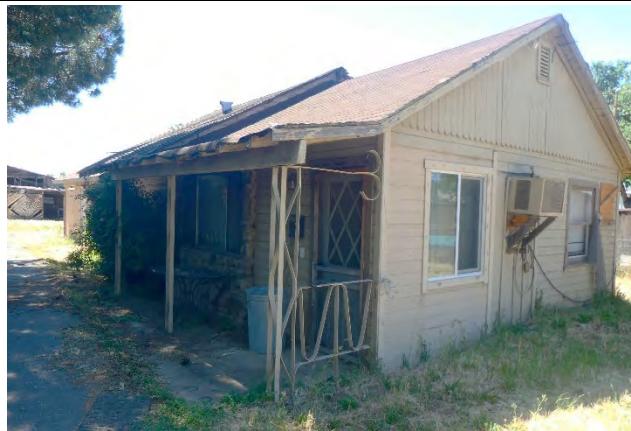
Image 3: Building B, east (left) and north (right) elevations, view facing southwest. Source: GPA, May 2024.

The north elevation has a forward-facing gable roofline with no overhang. A single wood vent is located in the upper gable and is surrounded by vertical wood siding with a scalloped edge. The remainder of the elevation is clad in MDF vertical siding, board and batten (within an infilled door opening), and horizontal wood siding. Fenestration includes a sliding, vinyl window, a double-hung, wood window, and a covered window opening (see Image 3 on Page 12).

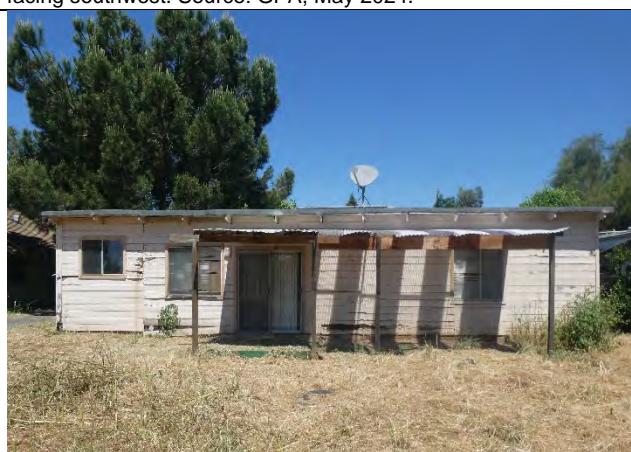
Image 5: Building C, south elevation, view facing north. Source: GPA, May 2024.

The primary elevation is oriented south towards Buildings D, E, and F. The elevation is a single, flat plane with exposed rafter tails and overhanging eaves above. The main entryway, a fully-glazed, sliding aluminum frame door, is located in the center of the elevation and is accessed by a wood landing covered in carpet. Fenestration consists of two sliding aluminum frame windows to the west and one sliding aluminum window to the east, all with wood framed openings. A flat, corrugated metal roof awning supported by square-shaped, wooden posts is located in front of the elevation (see Image 5 on Page 12).

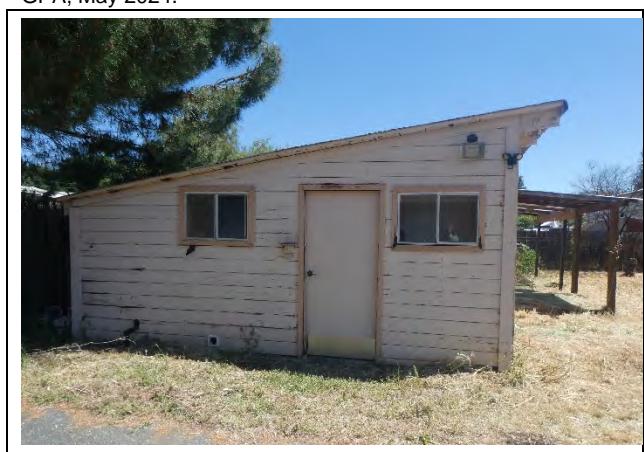
Image 6: Building C, west elevation, view facing east. Source: GPA, May 2024.

The west elevation is a single, flat plane with overhanging eaves. It has an irregular form due to the shed roof, with the southern end of the elevation angled above the northern end. A wood door is located in the center and is flanked on either side by a sliding aluminum frame window (see Image 6 on Page 12). The north elevation is a single plane with a flush roof and has a shallow setback from a wood fence. The elevation has five evenly spaced, sliding aluminum frame windows with wood framed openings. The east elevation mimics the form of the west elevation. It abuts the parcel line, is clad in vertical wood boards, and contains no fenestration.

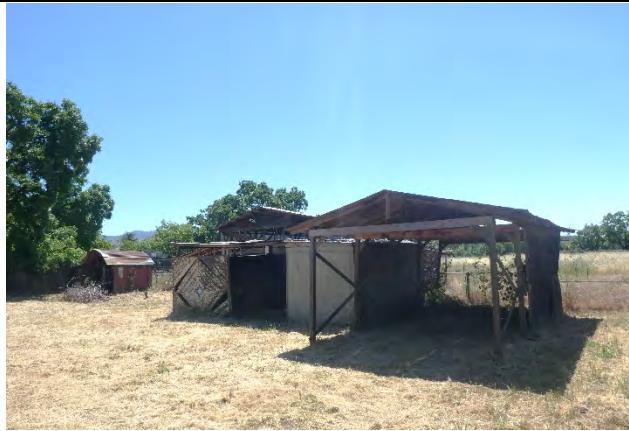
Image 7: Building D, north (left) and west (right) elevations, view facing south. Source: GPA, May 2024.

Building D was constructed between ca. 1982-1987 (see Image 7 on Page 13) and is not included in this evaluation as it is less than 50 years old and not likely to be of exceptional importance as defined by National Register criteria consideration G.

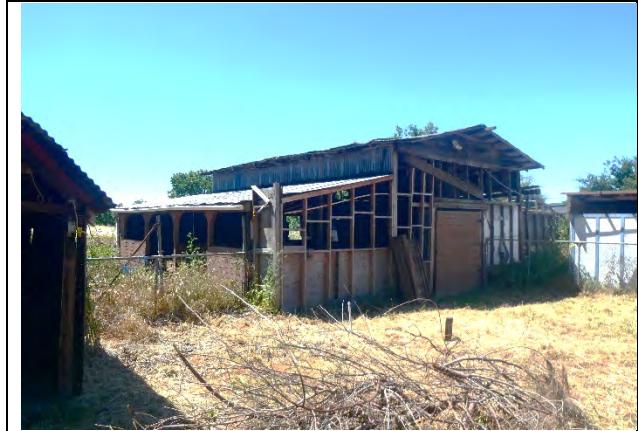
Image 8: Building E, east (left) and north (right) elevations, view facing southwest. Source: GPA, May 2024.

Building E features a one and two-story massing, some wood cladding, and a clerestory roof partially clad in corrugated metal panels. The clerestory roof features visible openings to the interior of the barn which are partially covered with corrugated plastic and metal panels where the lower shed roof intersects the raised gable section. Large sections of the north and east elevations are missing cladding and consist only of framing.

The primary elevation is oriented north and features horizontal wood cladding in the gable end and a double-height, swinging barn door located at the center (see Image 8 on Page 13). The east and west elevations have no fenestration and are partially clad in a combination of vertical wood planks, horizontal wood planks, and plywood (see Image 9 on Page 13). The south (rear) elevation was not accessible during the site visit, but appears to have a one-story shed roof addition.

The subject barn is a basic interpretation of a clerestory barn that lacks key character-defining features such as an opening to the gable peak and a hay hood. Additionally, large sections of cladding are missing or replaced with non-original materials and the clerestory window openings have been infilled with clear plastic and corrugated metal panels. Therefore, it does not exemplify a notable example of a clerestory barn as there is nothing unique or special about this design that would make it significant.

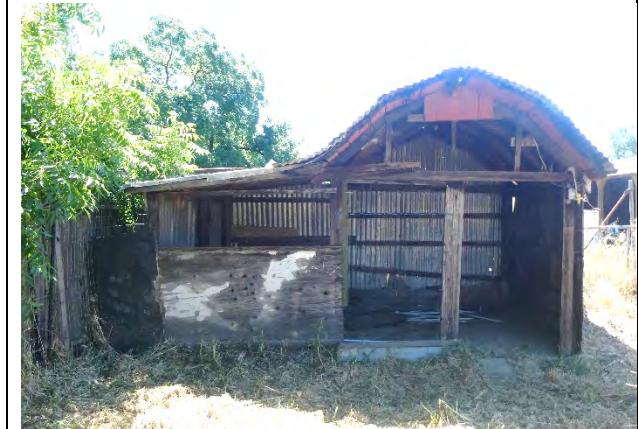
Image 10: Building F, north elevation, view facing south. Source: GPA, May 2024.

Building F is located east of Building E and is oriented north (see Image 10 on Page 13). The building has a gambrel roof with a flat roof extension to the east and was likely used as an animal pen/canopy. The north elevation is open to the interior of the building and the west elevation is clad in vertical wood planks (see Image 11 on Page 13). Both the south and east elevations are clad in corrugated metal panels.

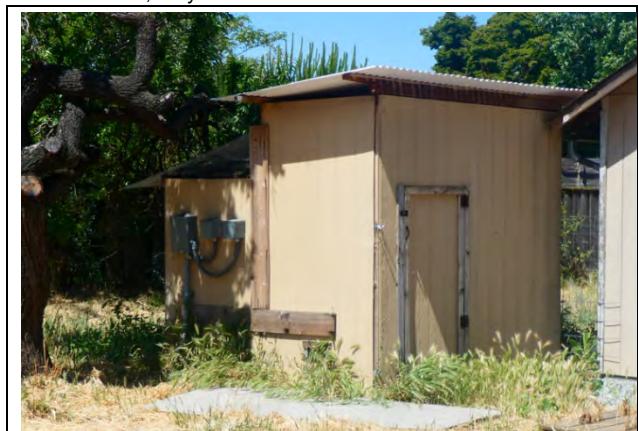
Image 12: Building G, south (left) and east (right) elevations, view facing northwest. Source: GPA, May 2024.

Building G was constructed between ca. 2020-2023 (see Image 12 on Page 13) and is not included in this evaluation as it is less than 50 years old and not likely to be of exceptional importance as defined by National Register criteria consideration G.

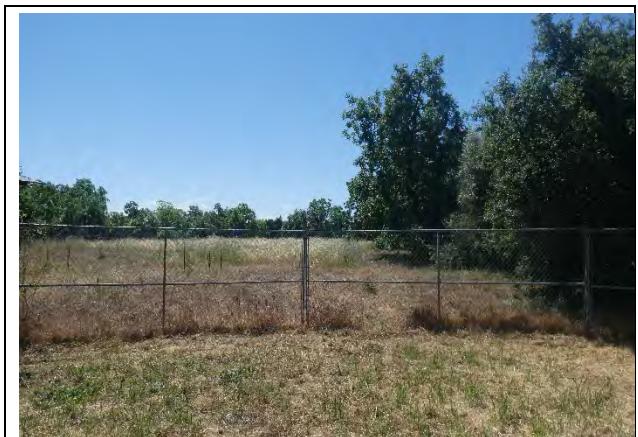
Image 18: Setting, rear of parcel with restricted access, view facing south. Source: GPA, May 2024.

The property located at 730 Diana Avenue is on an irregularly shaped, 1.96-acre parcel, located on the south side of Diana Avenue in the City of Morgan Hill. The northern half of the parcel is developed with seven (7) buildings (see annotated aerial image on Page 4): a two-story, single-family residence constructed in 1978 (Building A) (see Images 1 and 2 on Page 12); a one-story, single-family residence constructed ca. 1940-1948 (Building B) (see Images 3 and 4 on Page 12); a one-story, single-family residence constructed ca. 1940-1948 (Building C) (see Images 5 and 6 on Page 12); an ancillary building constructed ca. 1982-1987 (Building D) (see Image 7 on Page 13); a barn constructed ca. 1956-1965 (Building E) (see Images 8 and 9 on Page 13); a small, ancillary building constructed ca. 1956-1965 (Building F) (see Images 10 and 11 on Page 13); and a utility shed constructed ca. 2020-2023 (Building G) (see Images 12 on Page 13). The southern half of the parcel is located behind a chain link fence and consists of an undeveloped, open field (see Image 18 on Page 14).
