GEOTECHNICAL INVESTIGATION

**Butterfield Fire Station
17285 Butterfield Boulevard
Morgan Hill, California**

Project No. E9291-04-01

May 18, 2022

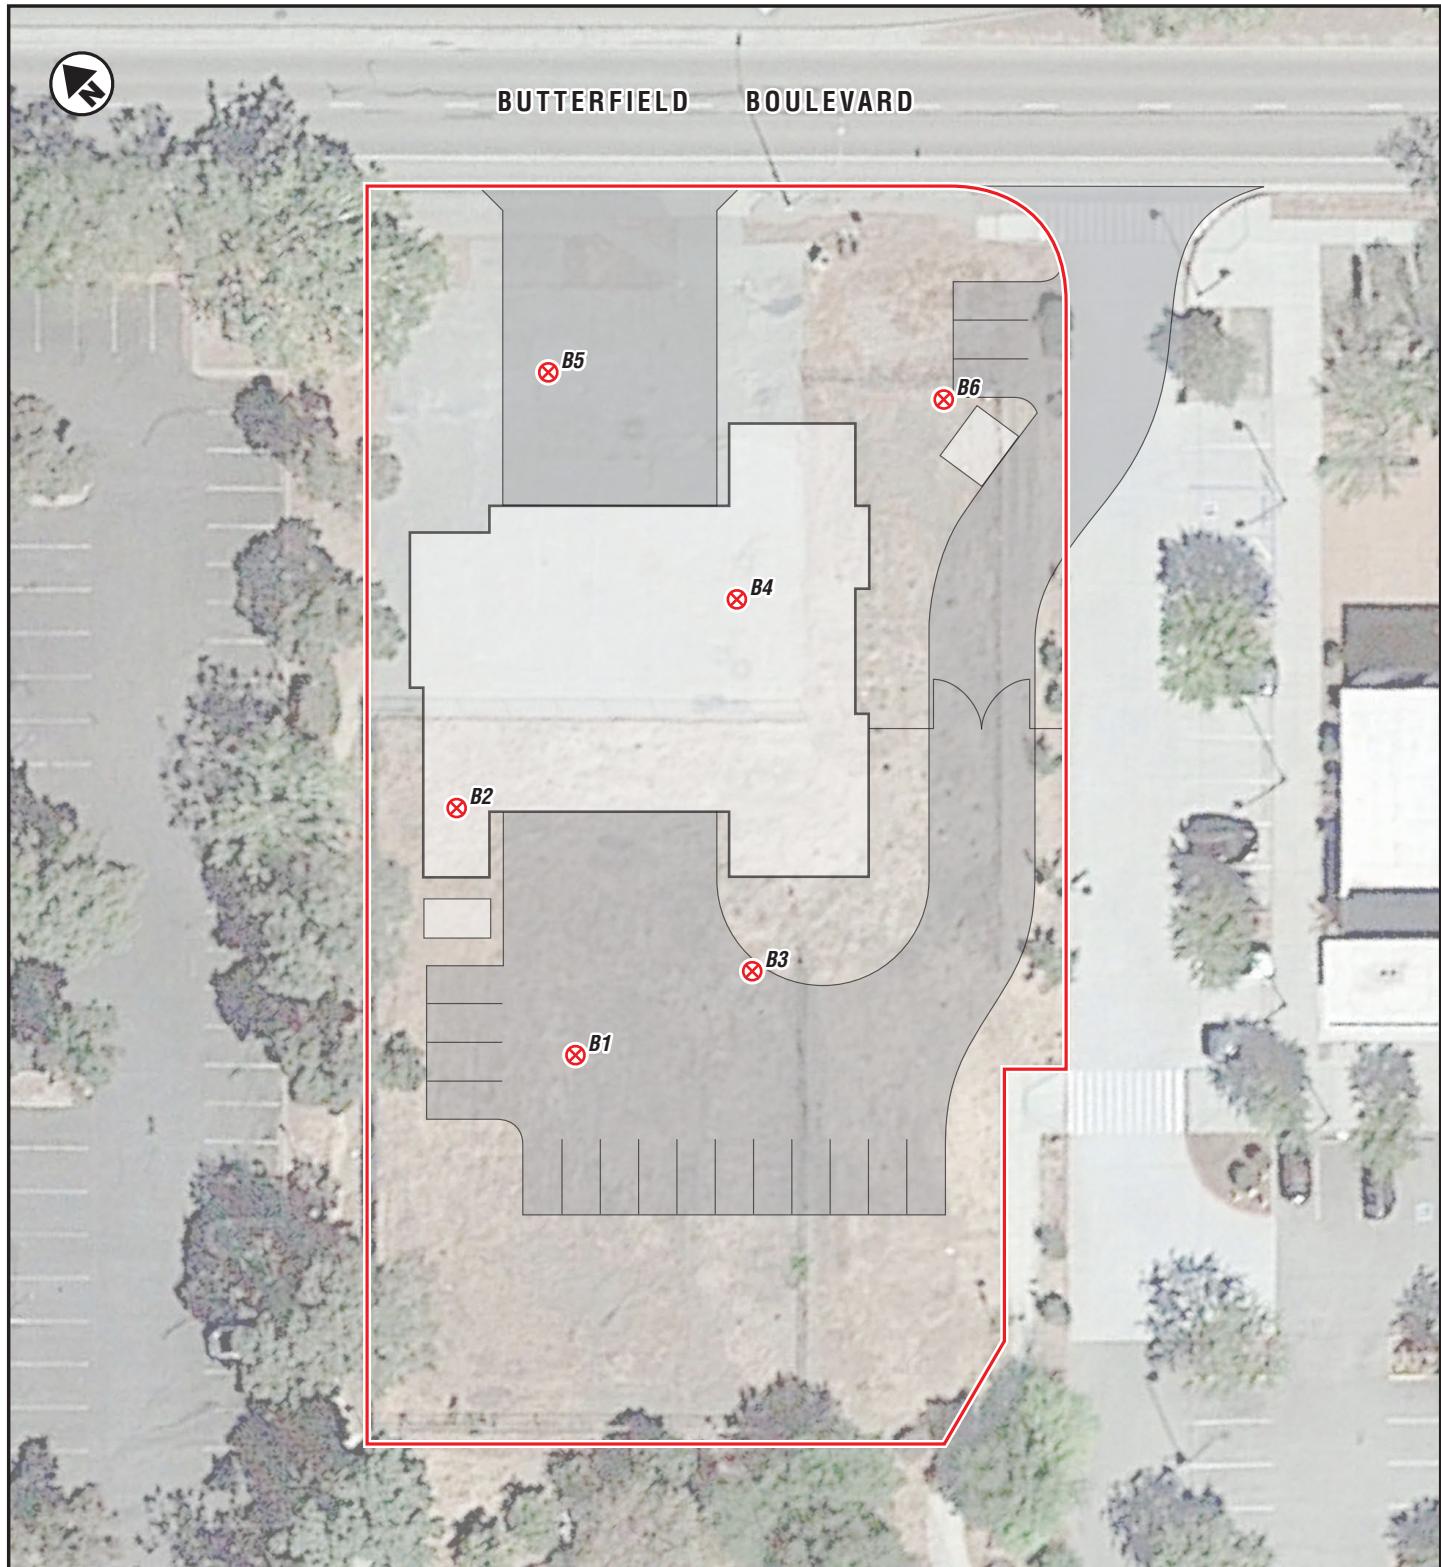
B6 Approximate Boring Location

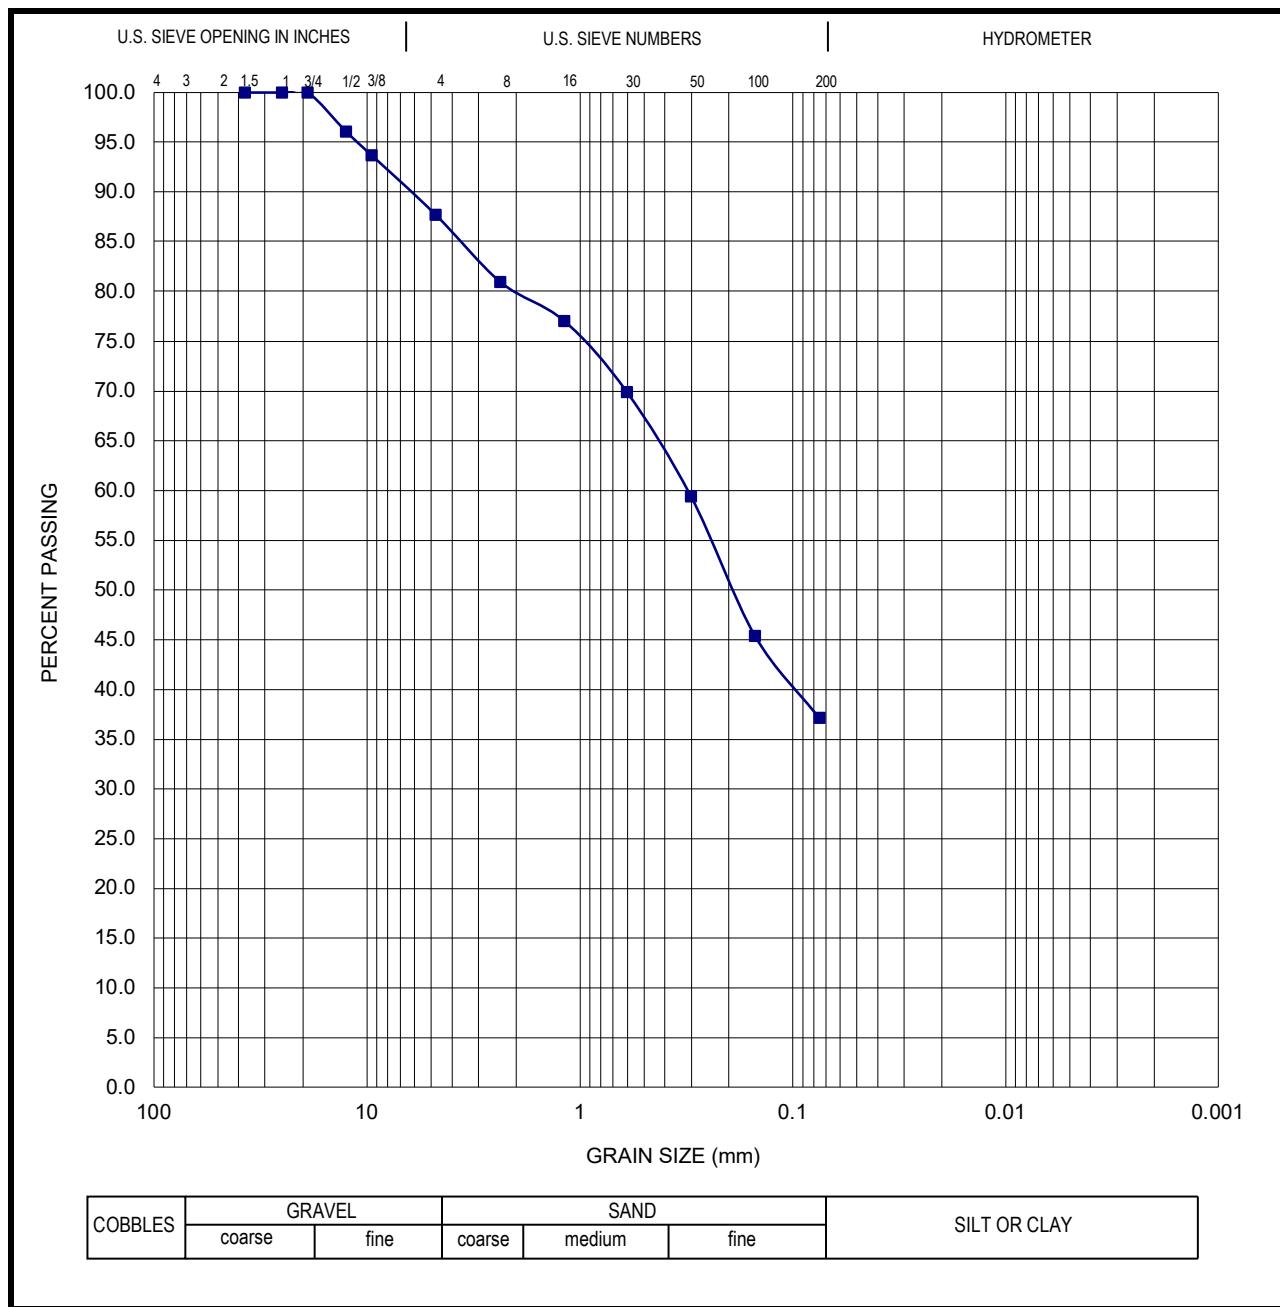
Figure B2

Boring: B4

Sieve Date: 1/10/2021

- Table B-I, Summary of Laboratory Atterberg Limits Test Results
- Table B-II, Summary of Laboratory Expansion Index Test Results
- Table B-III, Summary of Laboratory Grain Size Analyses - No. 200 Wash
- Table B-IV, Summary of Soil Corrosion Parameters
- Figures B1 and B2, Summary of Laboratory Particle Size Analyses
- Figure B3, Laboratory Unconfined Compressive Strength Test Results

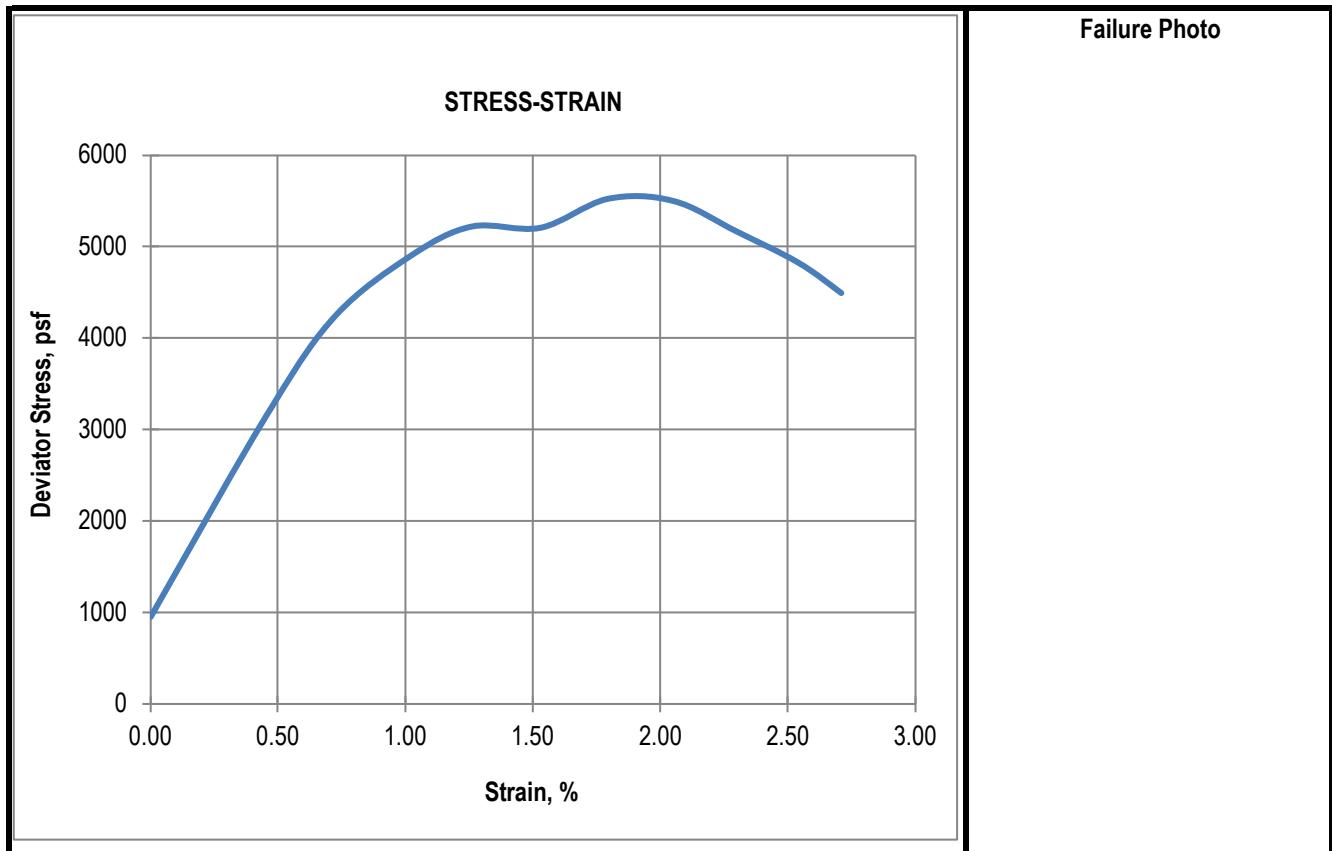
Sample Description	
Boring Number	B3
Sample Depth (feet)	2'
Material Description	brown & tan sandy CLAY w/ sandstone chunks
Initial Conditions at Start of Test	
Height (inch) average of 3	5.87
Diameter (inch) average of 3	2.38
Moisture Content (%)	8.9
Dry Density (pcf)	128.9
Estimated Specific Gravity	2.7
Saturation (%)	78.4
Shear Test Conditions	
Strain Rate (%/min)	0.4930
Major Principal Stress at Failure (psf)	5520
Strain at Failure (%)	1.8
Test Results	
Unconfined Compressive Strength (tons/ft ²)	2.8
Unconfined Compressive Strength (lbs/ft ²)	5520
Shear Strength (tons/ft ²)	1.4
Shear Strength (lbs/ft ²)	2760
