August 11, 2016

**Subject: Geotechnical Investigation Report**  
East Dunne Hillside Water Reservoir Project  
Morgan Hill, California

Cal Engineering & Geology, Inc. (CE&G) is pleased to submit this geotechnical investigation report to support the design for the East Dunne Hillside Water Reservoir Project in Morgan Hill, California. Our investigation included compiling and reviewing existing data; performing a field exploration program, geotechnical laboratory testing, engineering evaluations and analyses; and preparing this report.

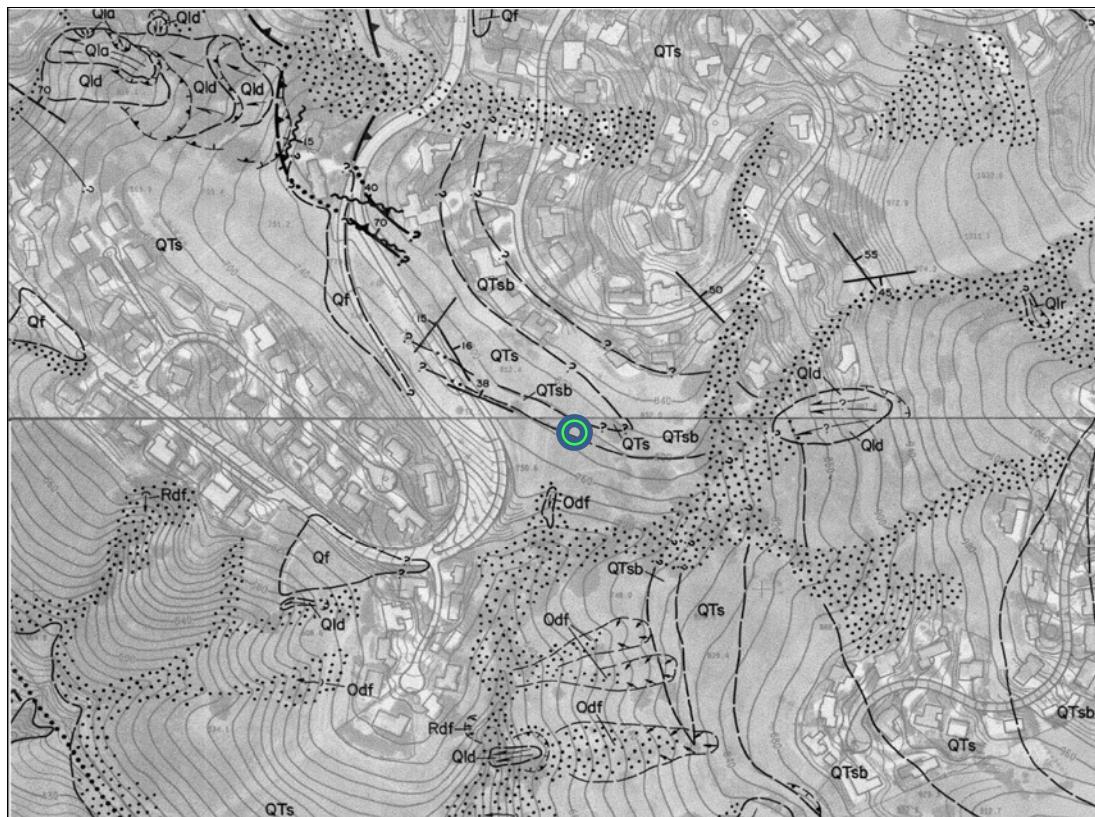
Plate 1 - Excerpt of PGE (1991), with site location at green circle.

Detailed geologic mapping performed for the City of Morgan Hill (PGE, 1991) shows similar rock types, although the names and ages assigned to the map units differs from those used by Wentworth and others. As shown on PGE (1991), the site is underlain by rocks of the Santa Clara Formation (map unit QTs on Plate 1 below). In general, this formation consists of “poorly to well-consolidated” non-marine sediments largely reflective of an alluvial fan setting. Within this formation are intervals of basalt lava flows and flow breccia (map unit QTsb); at least two of these intervals are shown on the City Geologic Map, although this mapping is somewhat interpretive.

The mapping of PGE (1991) found the extent of landslide deposits to be considerably less than was interpreted by Nilsen (1975). As shown on the City of Morgan Hill Geologic Map (see excerpt above), colluvium occupies the topographic swale areas. Localized landslide deposits are mapped within the general vicinity (within hundreds of feet), and are generally shown as confined to topographic swale areas.

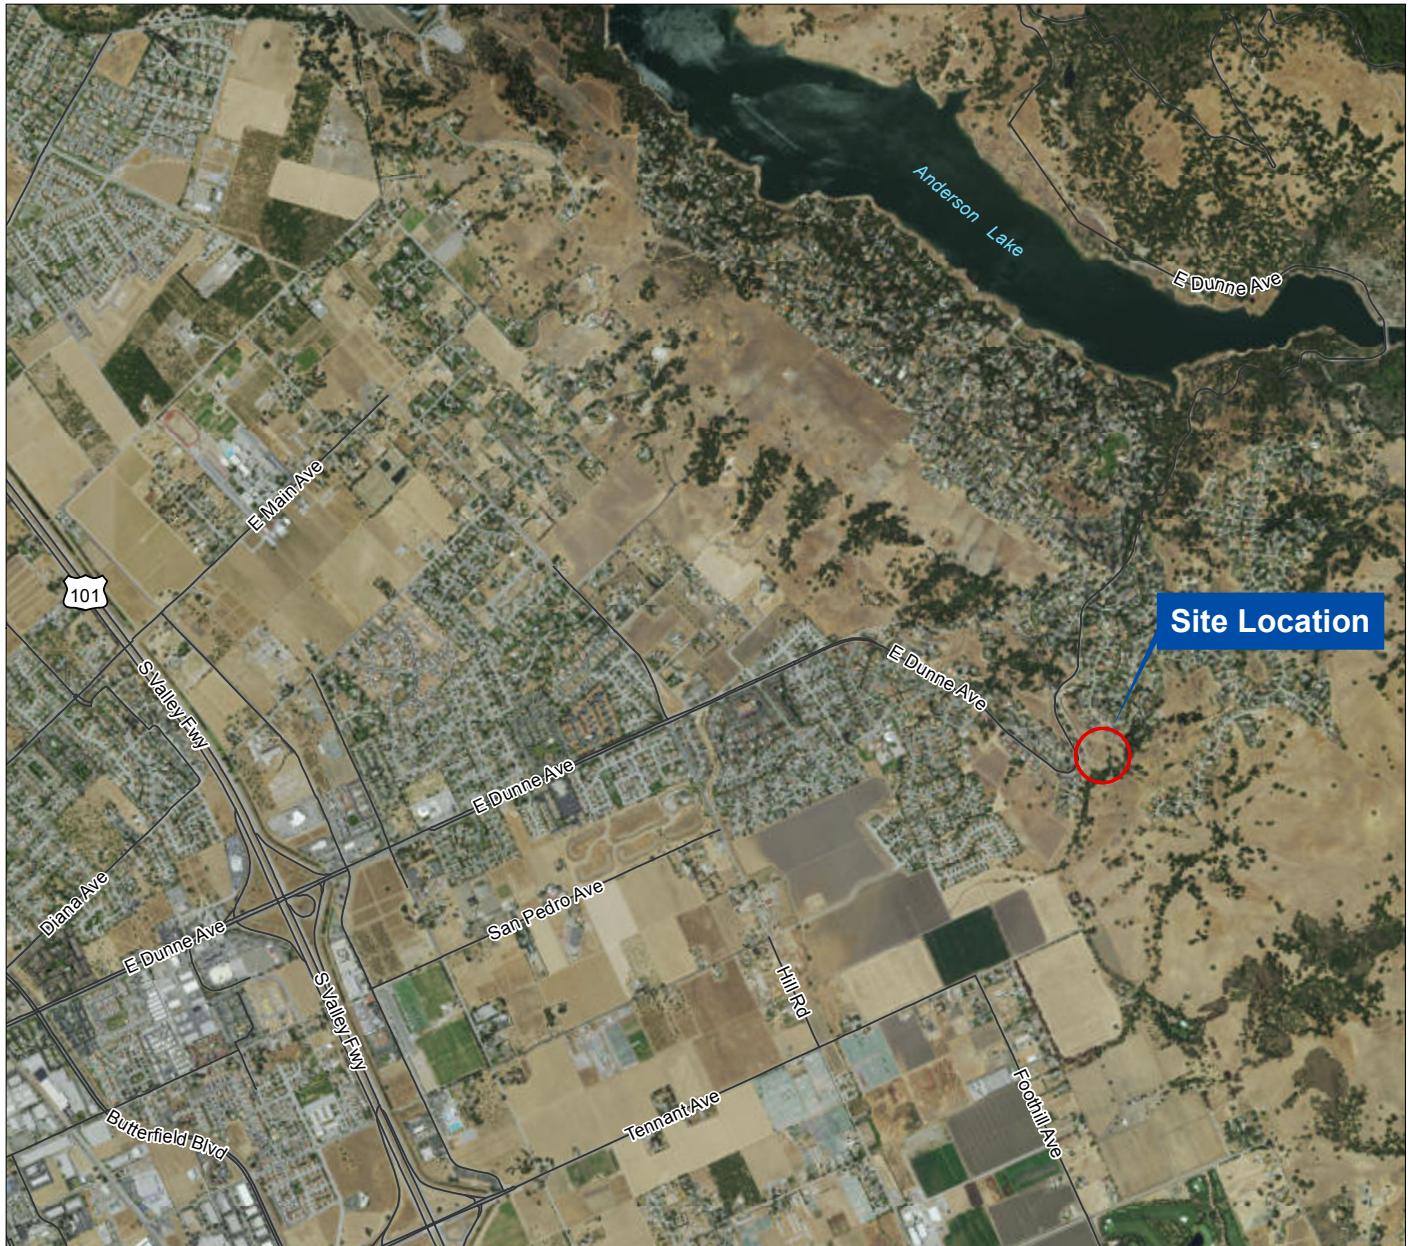
BASEMAP REFERENCE

1. ORTHOIMAGERY FROM ESRI.
2. STREET CENTERLINES FROM CALTRANS GIS DATA, 2016

Design of the City of Morgan Hill's (City) East Dunne Hillside Water Reservoir Project is led by Kennedy/Jenks Consultants. Cal Engineering & Geology, Inc. (CE&G) has provided geotechnical engineering services for the Project, which is located in the Jackson Oaks area of eastern Morgan Hill, California. In support of the Kennedy/Jenks, Cal Engineering & Geology's work included compiling and reviewing available pertinent geotechnical and geologic data; performing field reconnaissance, a field exploration and laboratory testing program, and geotechnical engineering analyses; developing geotechnical design recommendations for the proposed improvements; and preparing this report. The work has been completed to collect geotechnical data and provide engineering analyses and geotechnical design recommendations for the design team to design a water tank, pump station pad, access road, and associated retaining walls to be constructed at the site. The location of the Project is shown in Figure 1, Site Location Map.

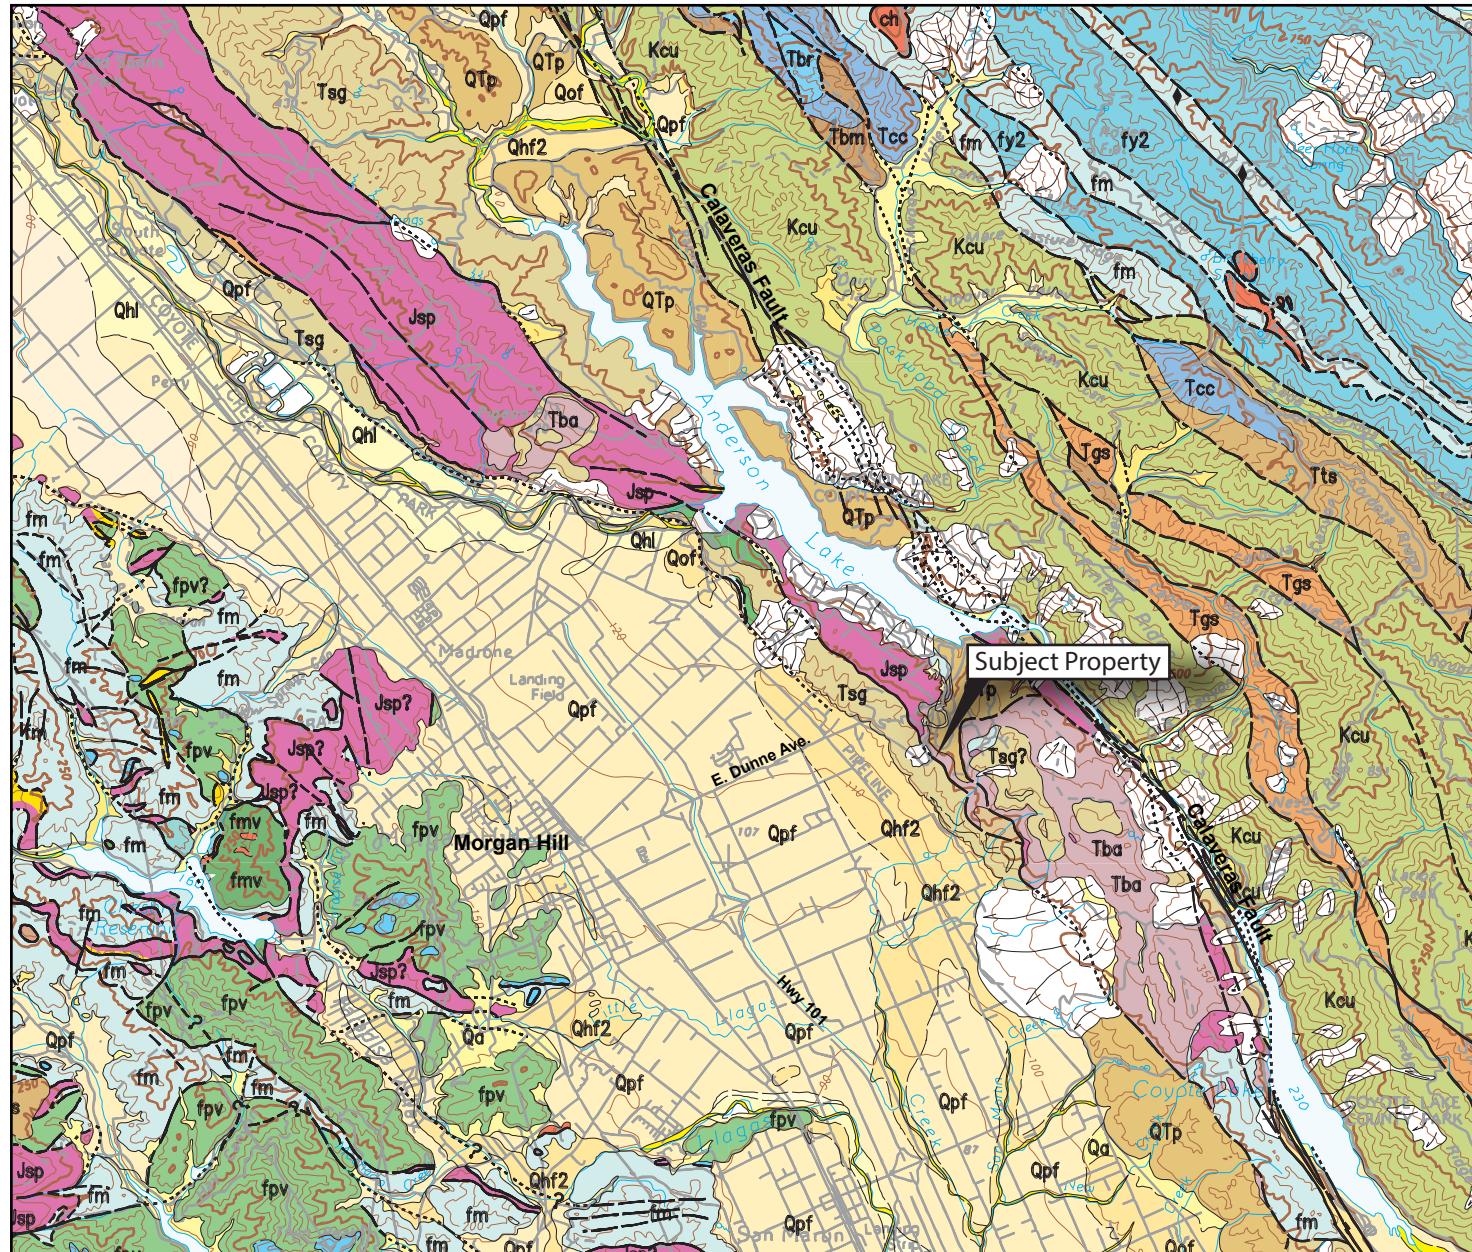
Base Map: Modified from Wentworth, et.al, 1999

Regional geologic mapping by Wentworth and others (1999), shows the upslope (eastern) part of the site as being underlain by the Pliocene-age Basalt of Anderson and Coyote Reservoirs. The western part of the site vicinity is mapped as being underlain by the Silver Creek Gravels of similar age. Slightly younger deposits known as the Packwood Gravels lie just upslope and east of the site. The Silver Creek Gravels are described as consisting of interbedded conglomerate, sandstone, siltstone, tuffaceous sediment, tuff, and basalt. The Basalt of Anderson and Coyote Reservoirs is described as pyroclastic andesite and basalt flows. The Packwood Gravels consist typically of gravel, cobbles, sandy conglomerate, silty sandstone, sandy siltstone and minor claystone. Regionally, all of these units overlie ophiolitic (ocean floor) and Franciscan Complex metamorphic rocks; the nearest exposures of these rocks is to the north, along the spine of the ridge crest west of Anderson Lake. Wentworth's mapping considered and incorporated earlier more detailed mapping by PGE (1991) described below.

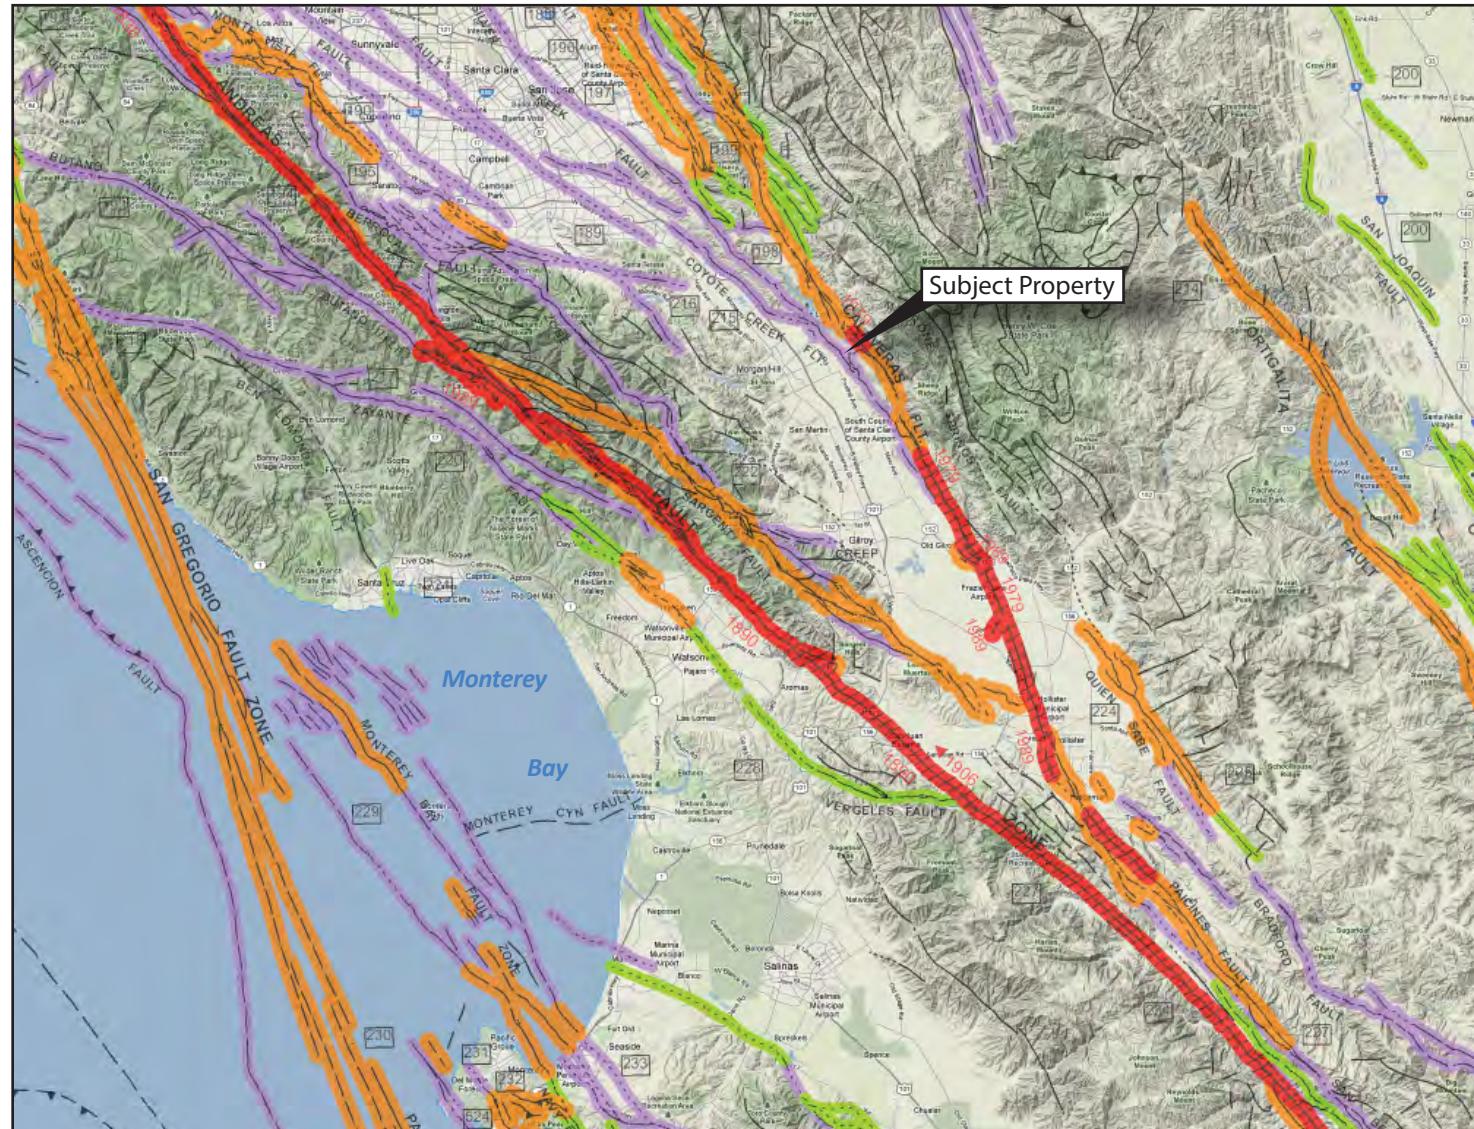
Base Map: Modified from Jennings and Bryant, 2010

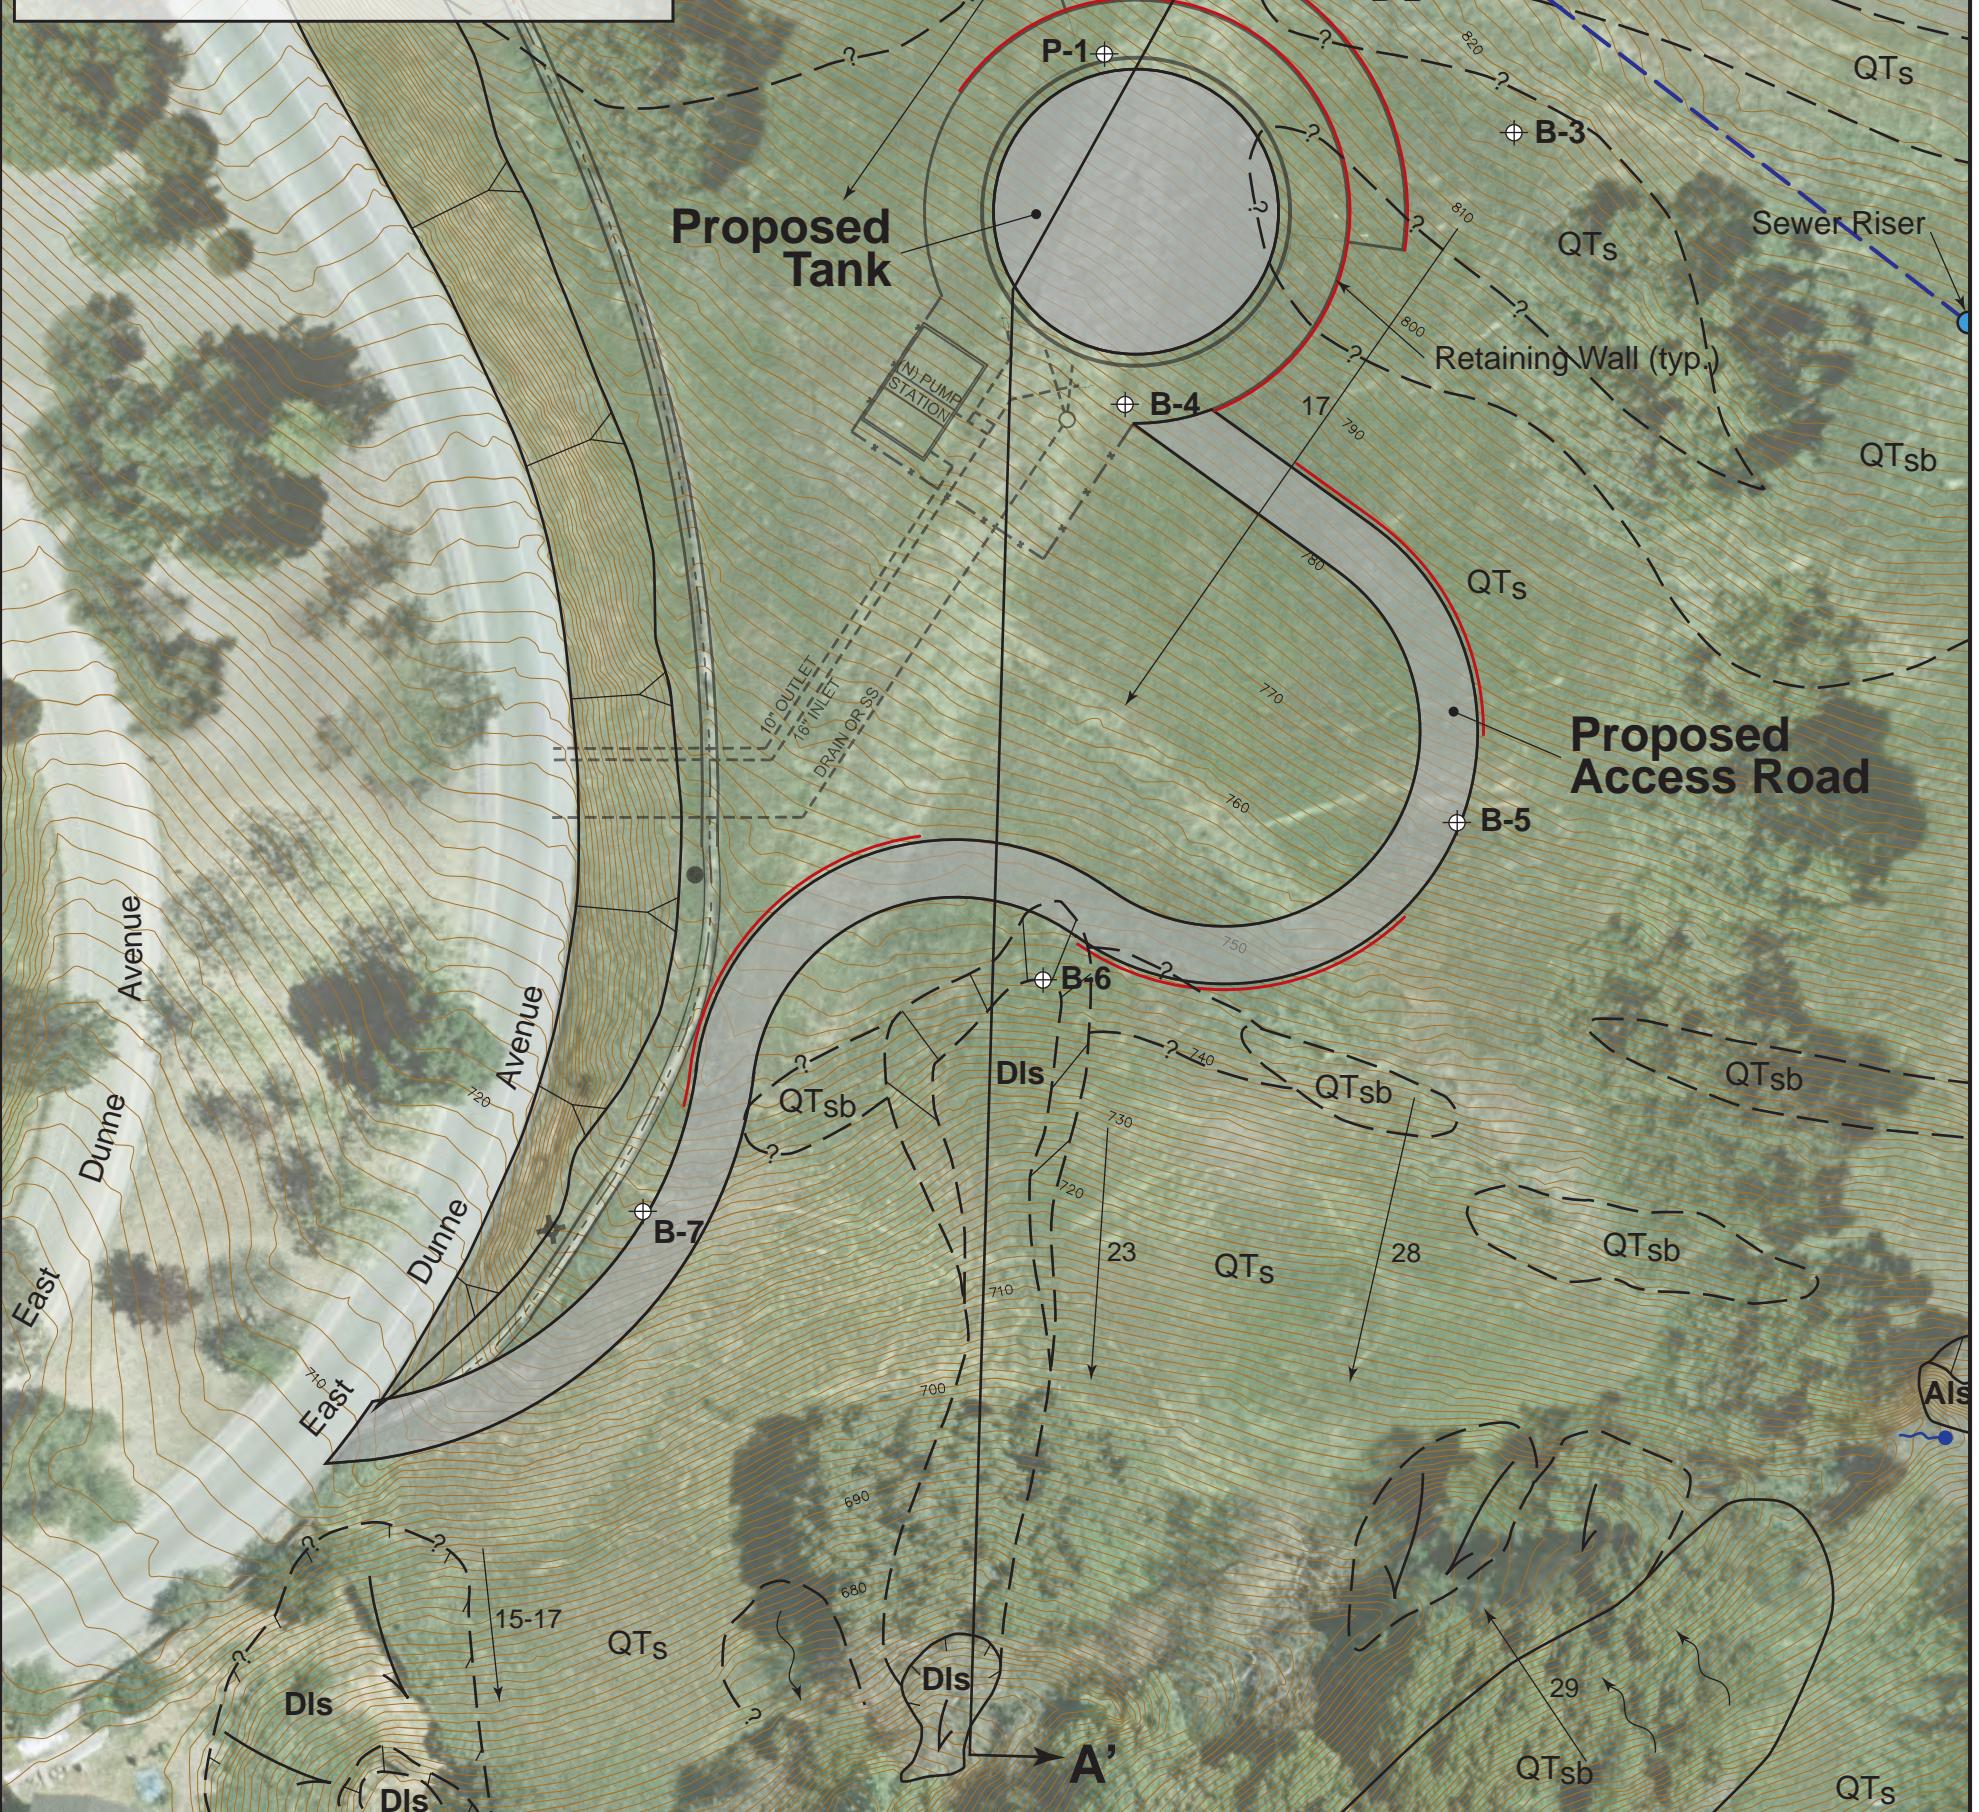
- Ef Existing fill
- QTsb Santa Clara Formation - Basaltic breccia and flows
- QTs Santa Clara Formation - Nonmarine sedimentary rock; variable from cobble sandstone to sandy claystone
- Geologic contact; dashed where inferred, dotted where concealed, queried where uncertain
- Slope aspect and gradient in degrees
- Landslide; arrows indicate direction of movement. Hachures indicate scarp area. Dls - dormant landslide; Als - active or recently active landslide
- Drill holes
- Probe
- Area of pronounced soil creep
- Spring
- Cut slope
- Line of geologic cross section

0 50 100  
Scale in Feet

Prior to drilling, CE&G coordinated with the City regarding selection of the final locations of the borings. CE&G marked, and coordinated a USA (Underground Service Alert); obtained an encroachment permit through the City of Morgan Hill; obtained an exploratory boring permit from the Santa Clara Valley Water District; and obtained a hydrant water meter (through City of Morgan Hill DPW). The locations of the completed borings were marked in the field and recorded by measuring with a tape from established points of reference and by using a handheld GPS device. Following drilling, the completed borings were surveyed by the Mark Thomas & Co. surveying team, for plotting as shown on Figure 4, Vicinity Geologic Map.

Based on the results of our investigation, it is our opinion the site is geologically and geotechnically suitable for the proposed improvements shown on our Vicinity Geologic Map (Figure 4), provided the recommendations presented in this report are followed.

The proposed pump station structure is anticipated to be constructed over an engineered fill pad (see Figures 4 and 5) and may be supported on conventional shallow foundations founded on compacted engineered fill or undisturbed native soils. The footings should be embedded at least 18 inches below rough pad grade or lowest adjacent finish grade, whichever provides a deeper embedment. Footings may be designed using a net allowable soil bearing pressure of 2,500 pounds per square foot (psf) for dead plus live loads. This value may be increased by one-third when considering short-term loads such as wind and seismic forces. Reinforcement for the foundations should be determined by the project structural engineer.

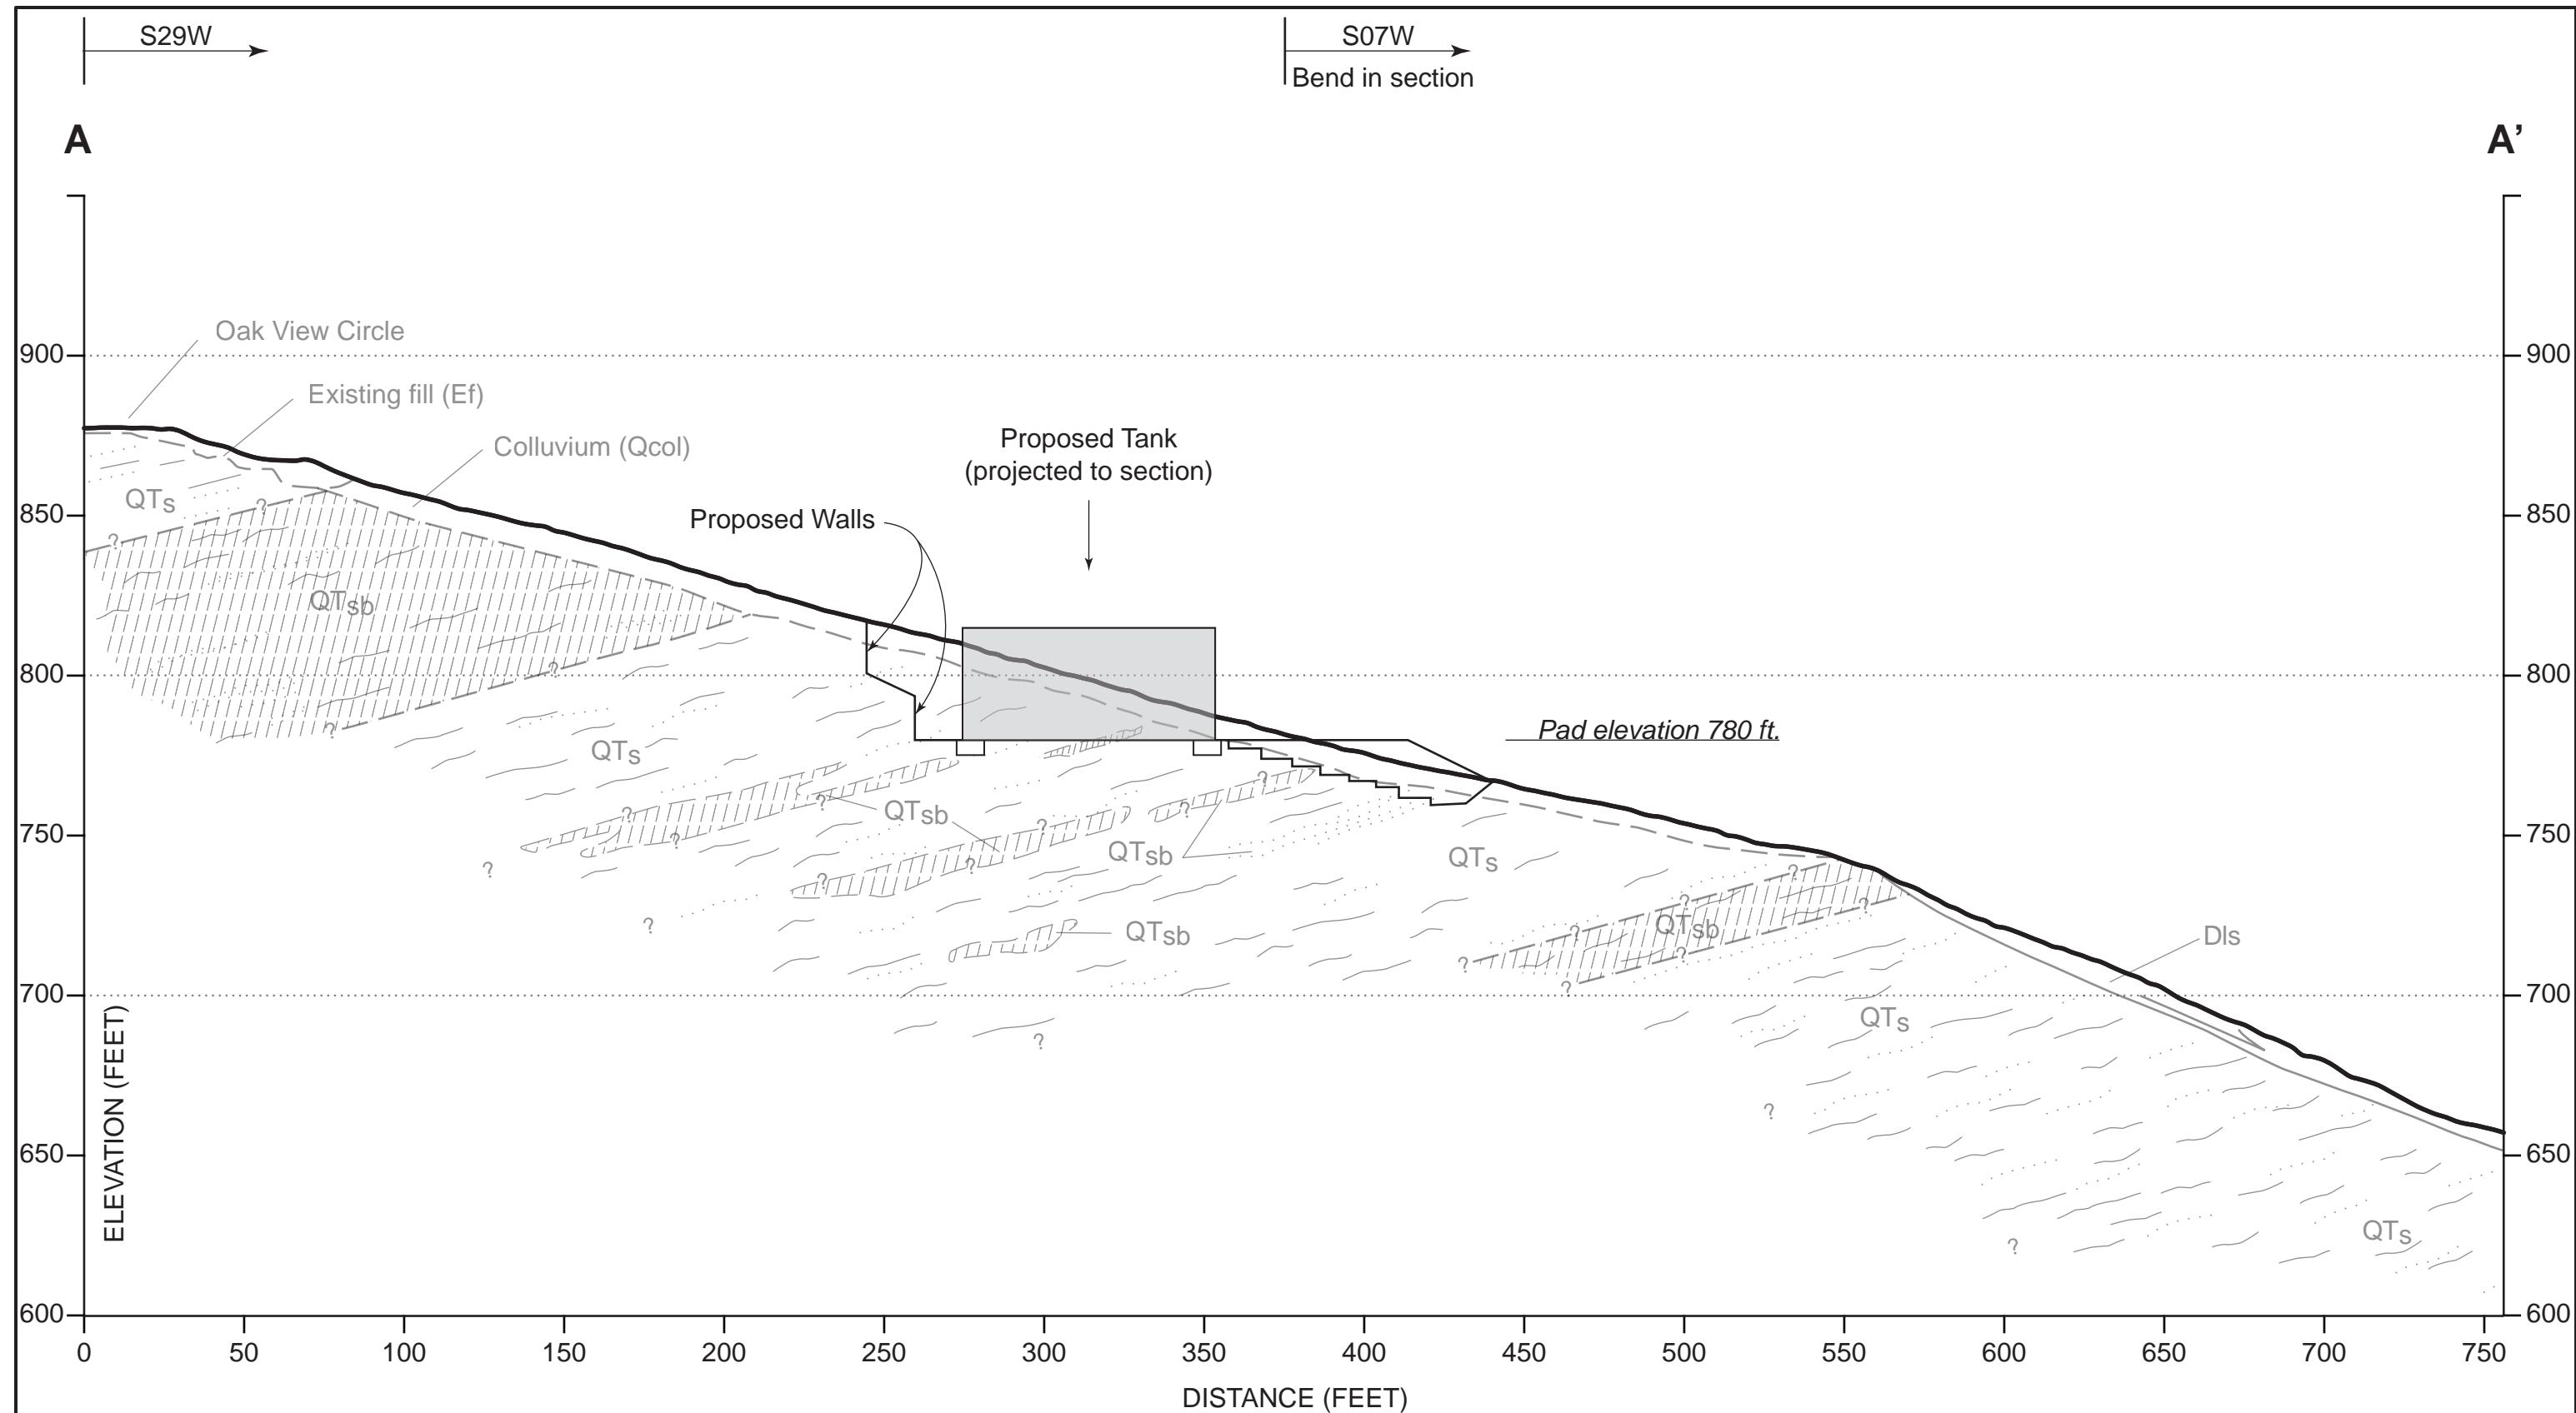
**Notes:**

1. Colluvium mantle not shown on Vicinity Geologic Map (Figure 4).
2. Subsurface extent and nature of QTsb is speculative.
3. See text for discussion of conceptual tank, wall and pad footprints shown.
4. Improvements shown schematically; location adjusted laterally to preserve elevation, and provide cut pad in rock.

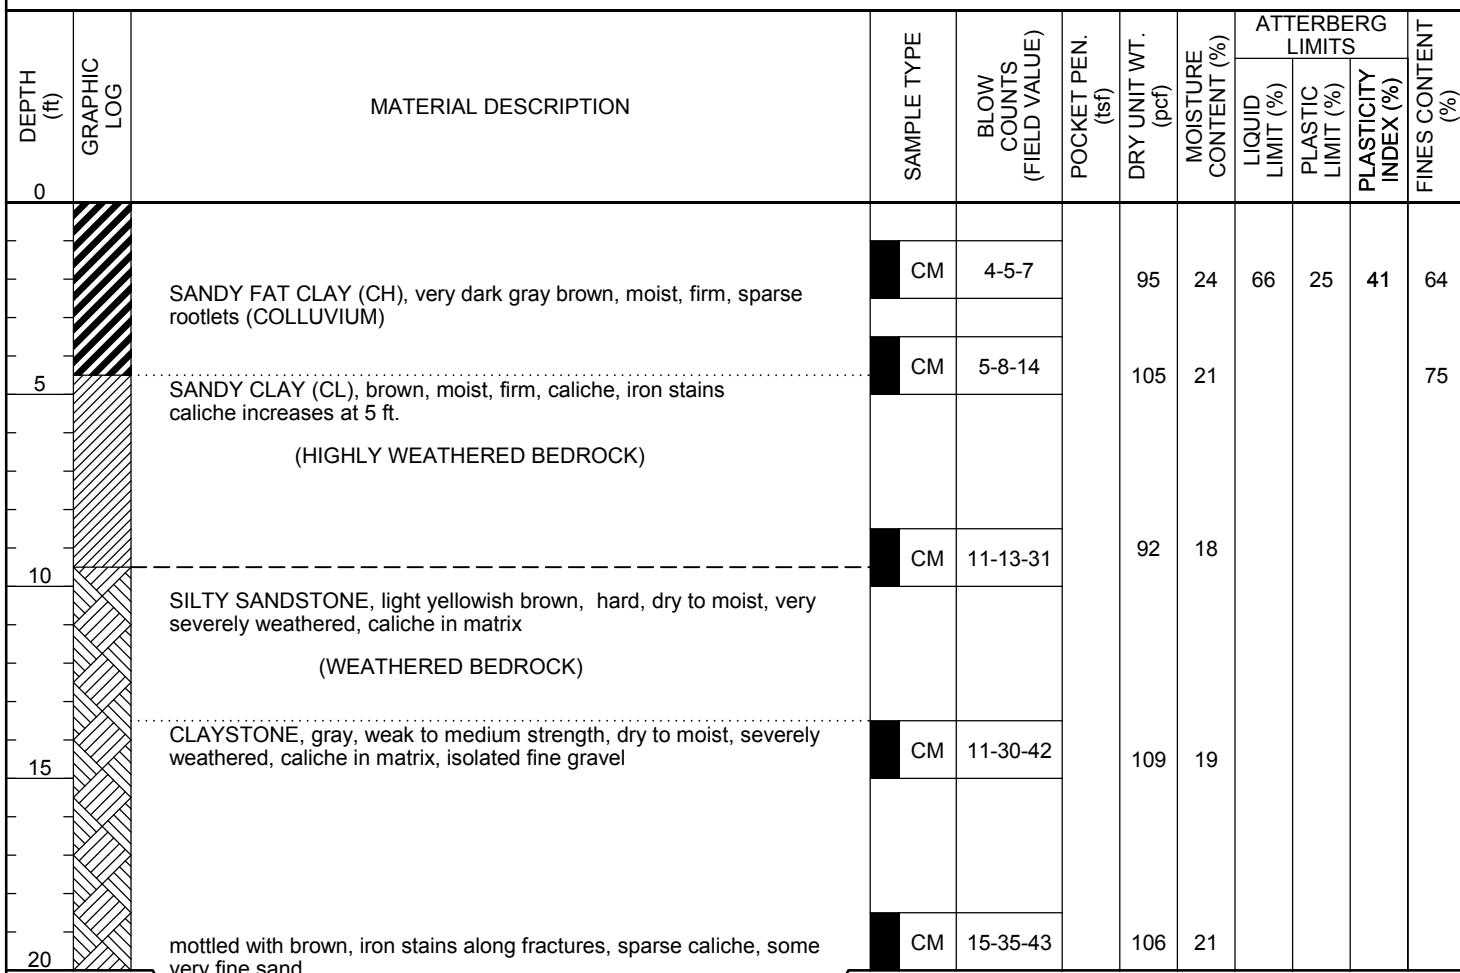
Bottom of borehole at 20.0 ft. Borehole backfilled with grout.

CLIENT Kennedy-Jenks PROJECT NAME E. Dunne Tank  
 PROJECT NUMBER 160200 PROJECT LOCATION Morgan Hill, California  
 DATE STARTED 4/12/2016 COMPLETED 4/12/2016 GROUND ELEVATION   DATUM Site Specific HOLE SIZE 6 in.  
 DRILLING CONTRACTOR Britton Exploration COORDINATES: LATITUDE 37.13733 LONGITUDE -121.59485  
 DRILLING RIG/METHOD 6-in. Solid Flight Auger GROUNDWATER AT TIME OF DRILLING --- N/A  
 LOGGED BY R. Briseno CHECKED BY   GROUNDWATER AT END OF DRILLING --- N/A  
 HAMMER TYPE 140 lb hammer with 30 in. autotrip GROUNDWATER AFTER DRILLING --- N/A

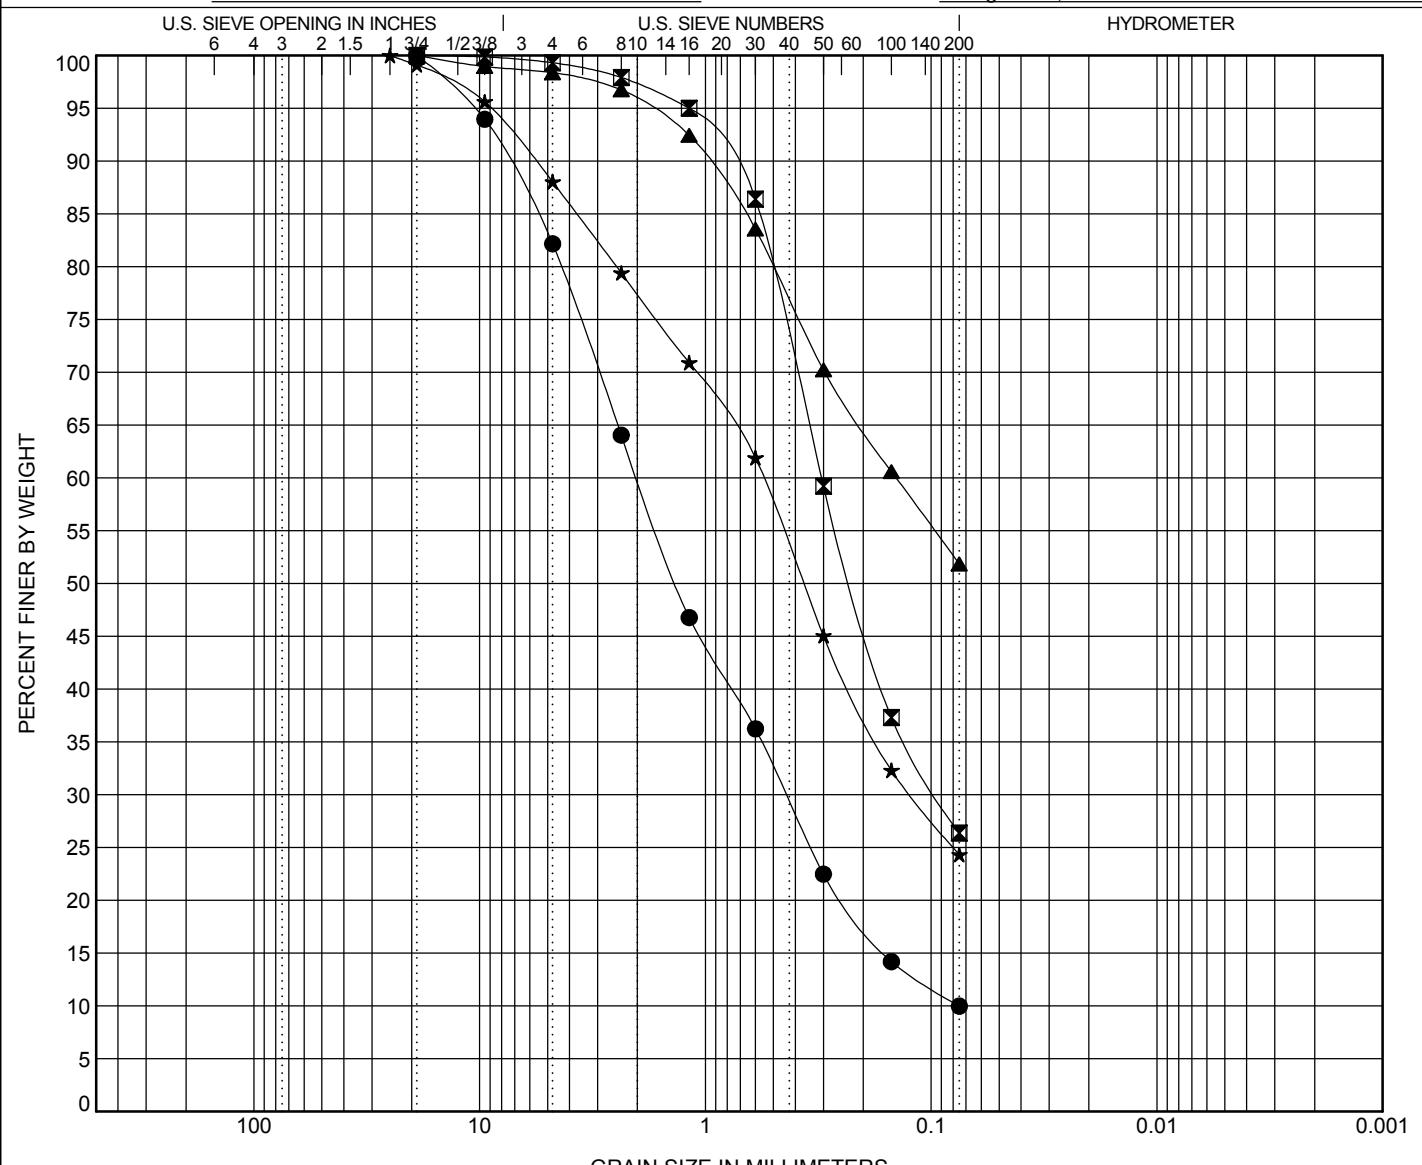
BOREHOLE	DEPTH	DATE TESTED	Classification					LL	PL	PI	Cc	Cu	
			GRAVEL		SAND								
COBBLES	coarse	fine	coarse	medium	fine								
● B-2	9.5	4/22/2016	Olive Brown Well graded Sand with Silt									1.27	26.63
☒ B-2	14.5	4/22/2016	Olive Gray Silty Sand										
▲ B-3	6.0	4/22/2016	Light Olive Brown Sandy Clay										
★ B-3	20.0	4/22/2016	Dark Olive Silty Sand										
BOREHOLE	DEPTH	D100	D60	D30	D10	%Gravel	%Sand	%Silt	%Clay				
● B-2	9.5	19	2.006	0.438	0.075	17.8	72.2		10.0				
☒ B-2	14.5	19	0.306	0.094		0.7	73.0		26.4				
▲ B-3	6.0	19	0.143			1.6	46.5		51.9				
★ B-3	20.0	25	0.555	0.123		12.0	63.7		24.3

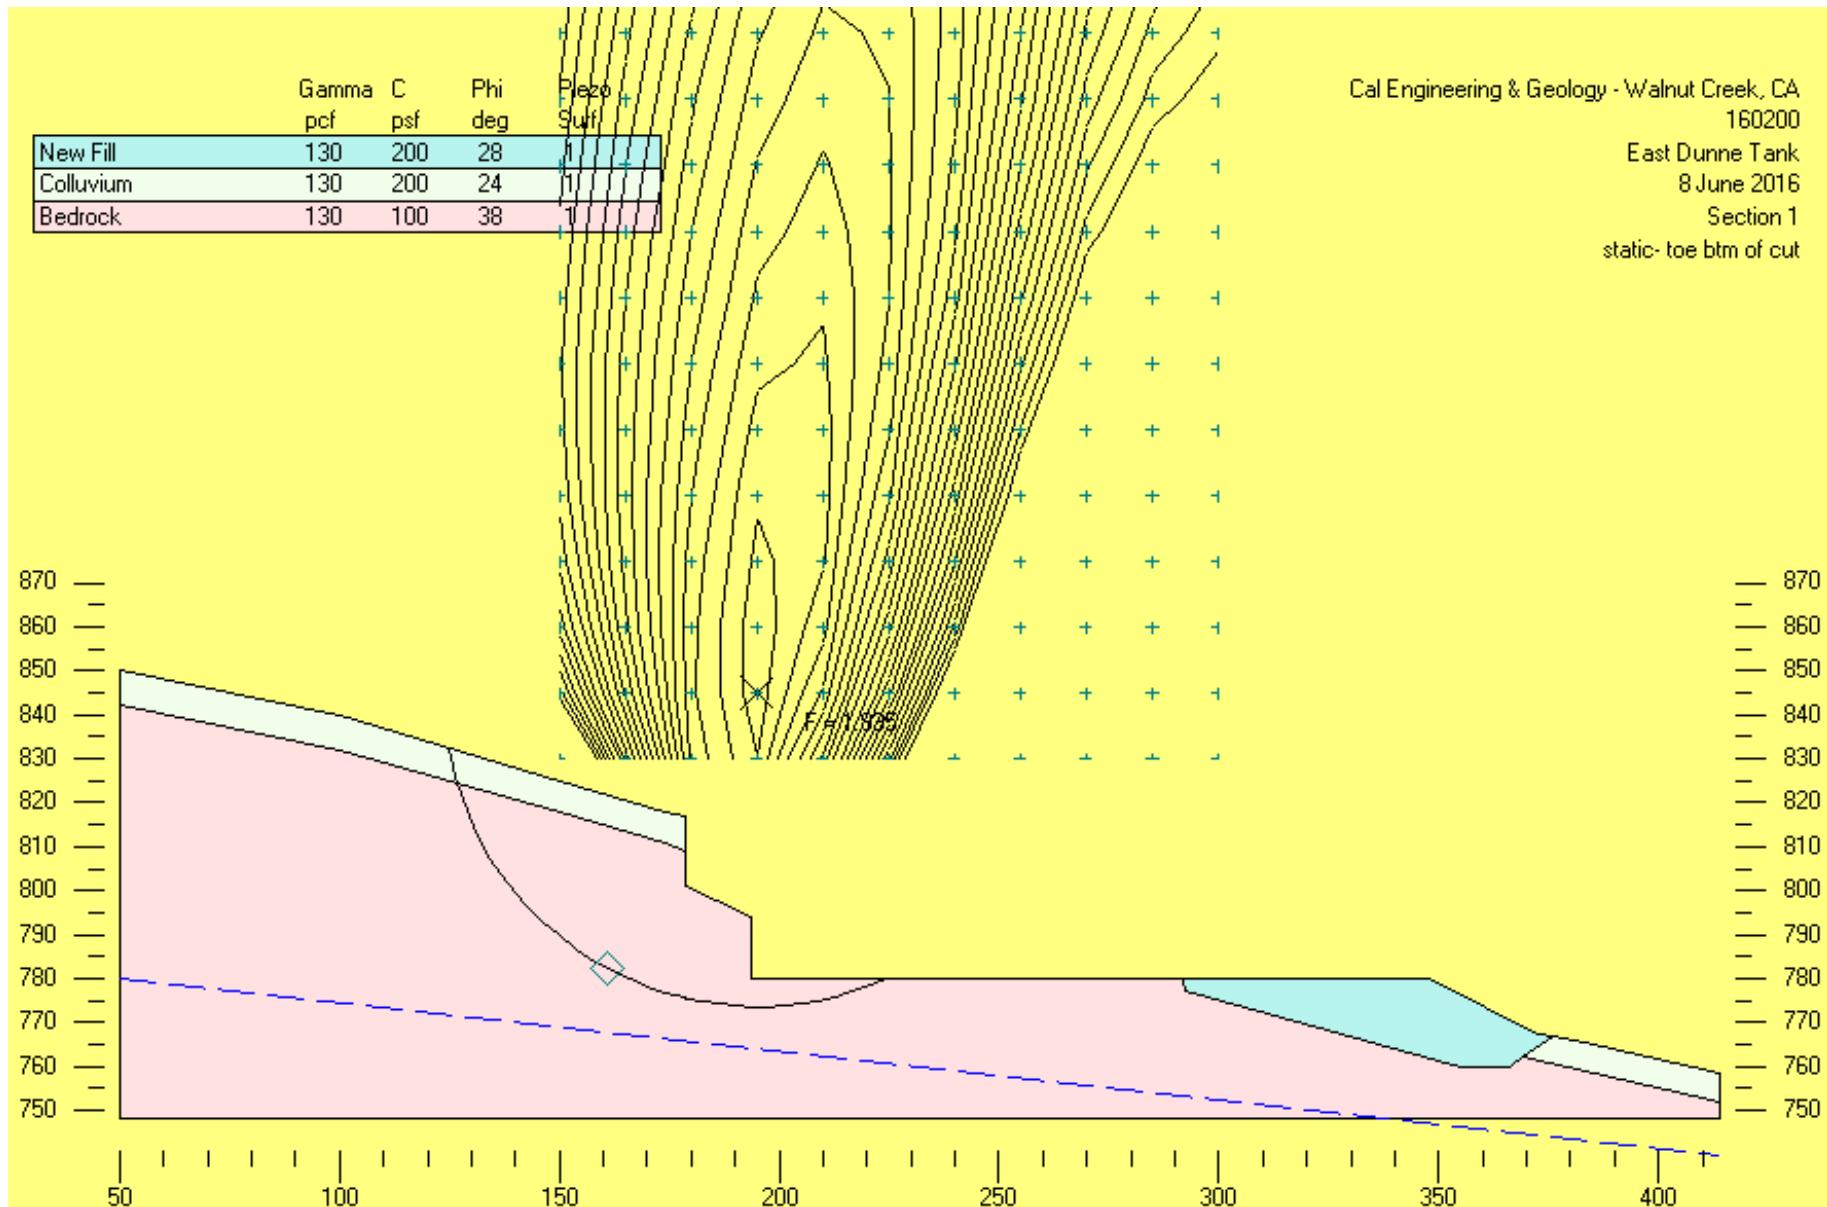
GSLOPE Static Slope Stability Calculation Output
